**An archaeological evaluation at
the Blackwater Hotel,
Church Road, West Mersea,
Colchester, Essex
March 2003**

**report prepared by
Laura Pooley**

CAT Report 223
March 2003

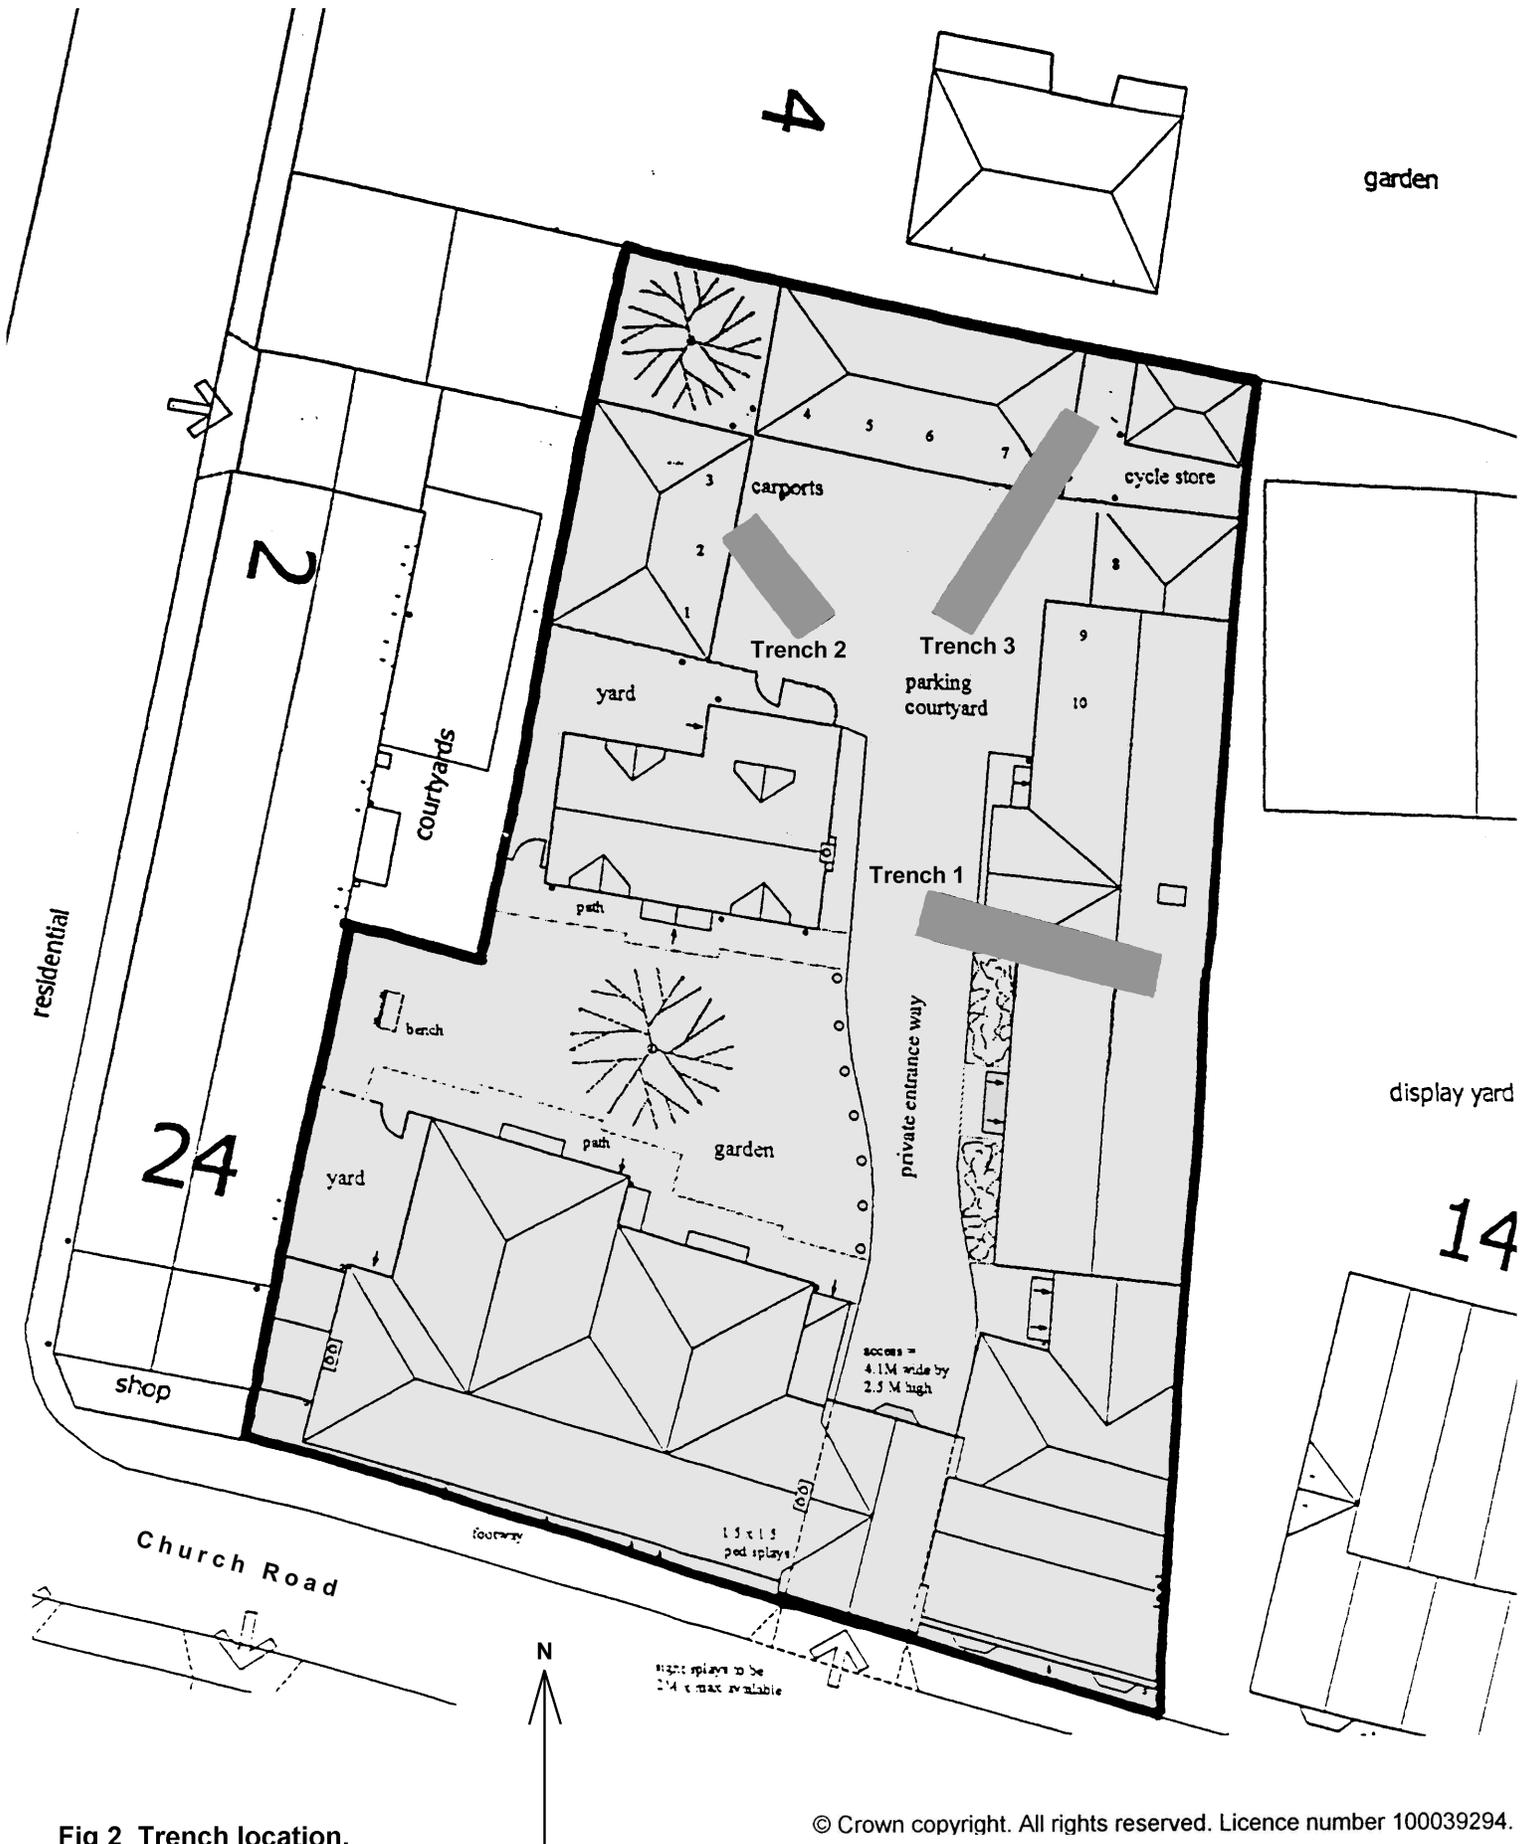
Fig 2 Trench location.

- 5.1** Three trenches were excavated within the site. Trenches 1-3 were each 1.5m wide and totalled 20m in length (8m, 4m and 8m long respectively). A scan with a cable/service detector produced a number of signals close to the not yet demolished hotel building, so the trenches were located within the yard and garden at the rear of the site (Fig 2).

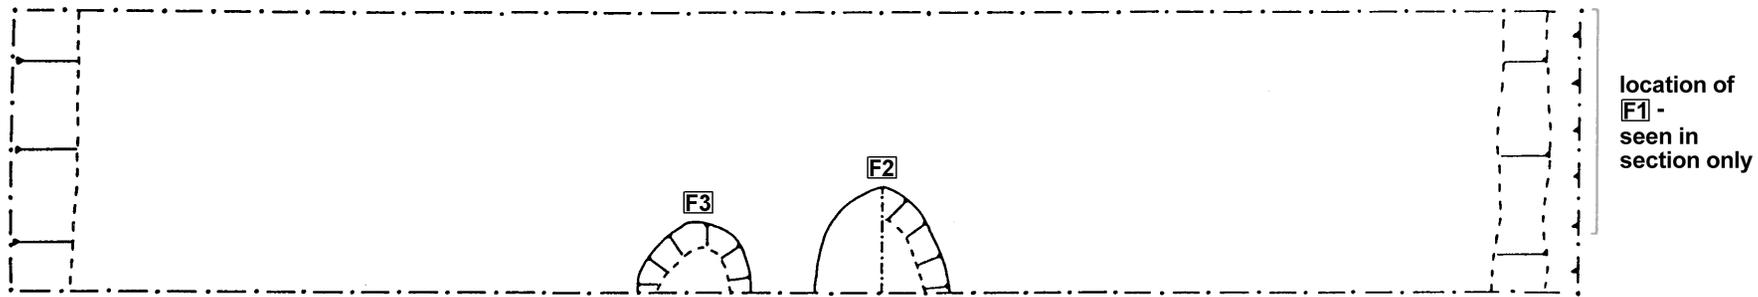
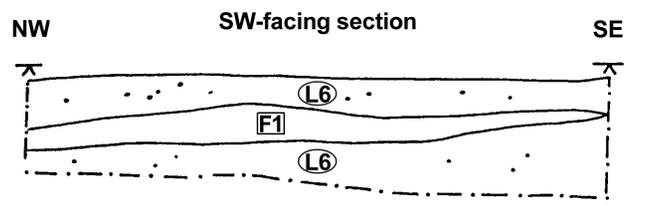
Fig 3 Trench 3: plan and sections.

Trench 3 was 1.5m wide x 8m long x 550mm deep, dug in the garden of the hotel through a layer of topsoil (L6, a mid-dark brown silty loam) to a depth of approximately 550mm straight onto natural (L5). Three features were noted in this trench. Feature or F1 was a modern pit full of slate (seen in section), F2 was a lime-lined pit containing a jam jar and other modern material, and F3 was a lime pit (Fig 3).

7.2 Three features were recorded in Trench 3, all of which appear to be modern.
