**CAT Report 1905
issued April 2023**

**Historic building recording of Shell House, St
Osyth's Priory Park, St Osyth, Essex, CO16 8GW:
February 2023**

**Historic building recording of Shell House, St
Osyth's Priory Park, St Osyth, Essex, CO16 8GW**

**CAT project ref.: 2023/01g
CAT Report 1905**

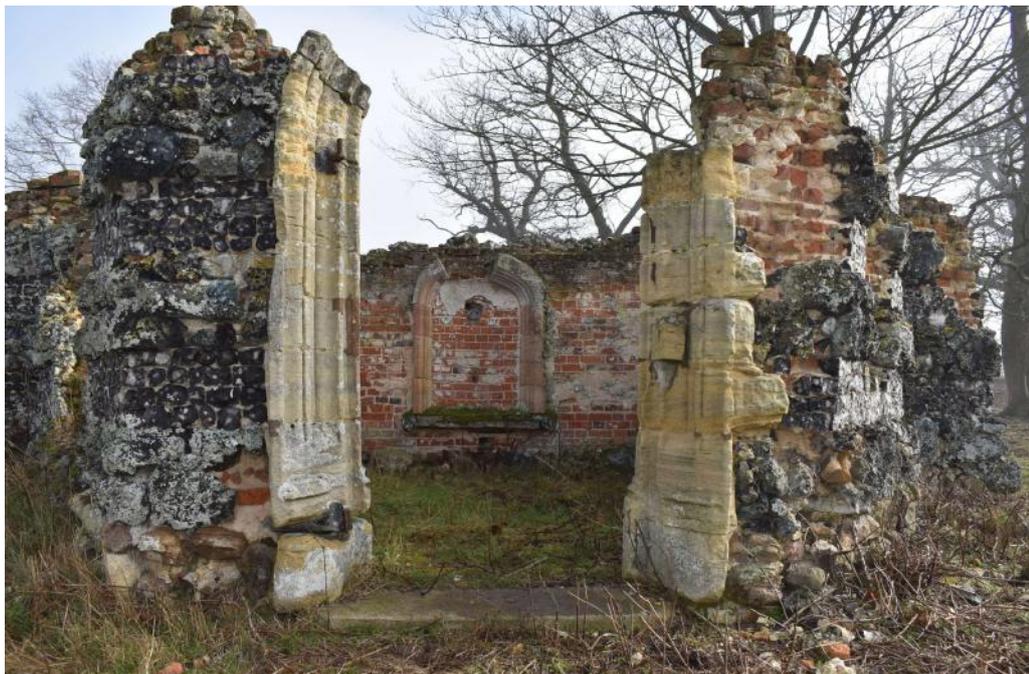
On the western elevation is a doorway with a carved stone surround (Photograph 11). There are two iron pintles on the northern side and a mortice carved into the stone on the southern side. There are remains of a window opening on both the northern and southern elevations: both are degraded but the northern more so. There is evidence of a brick window-sill on the southern opening. On the interior of the folly, the windows were surrounded with carved stone blocks and slag. Photographs 3 and 4 show the windows originally had a pointed arch shape, evidence of this shape can be seen on the window opening in the southern wall (Photograph 14).

Photograph 11 Detail of doorway on northern elevation. Photograph taken facing east south-east.

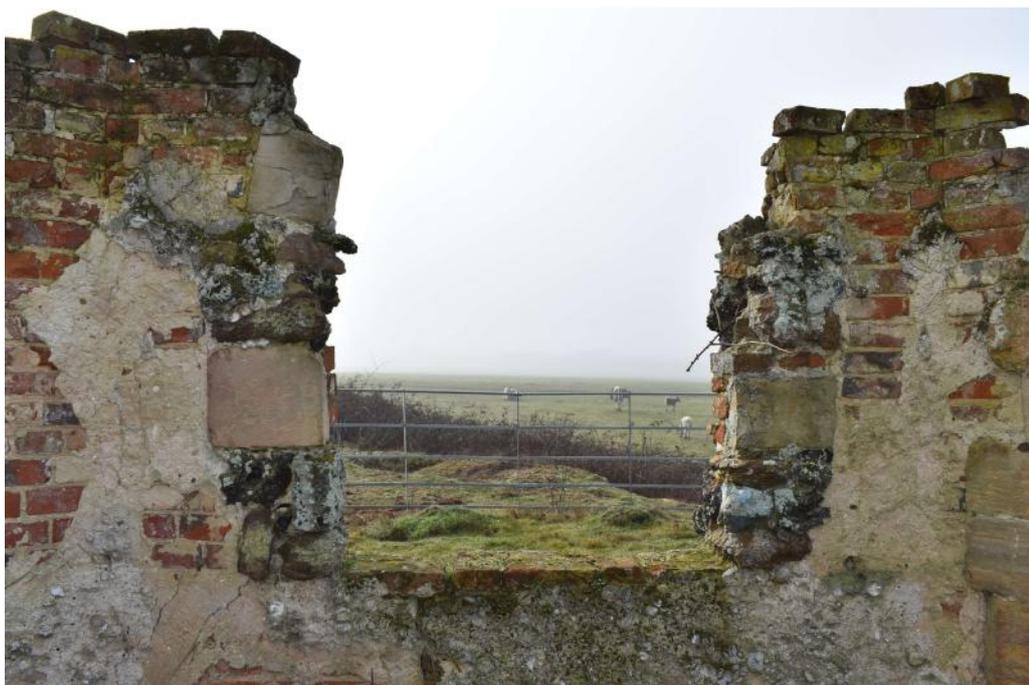
Photograph 14 Internal detail of window opening on southern wall. Photograph taken facing south-west.

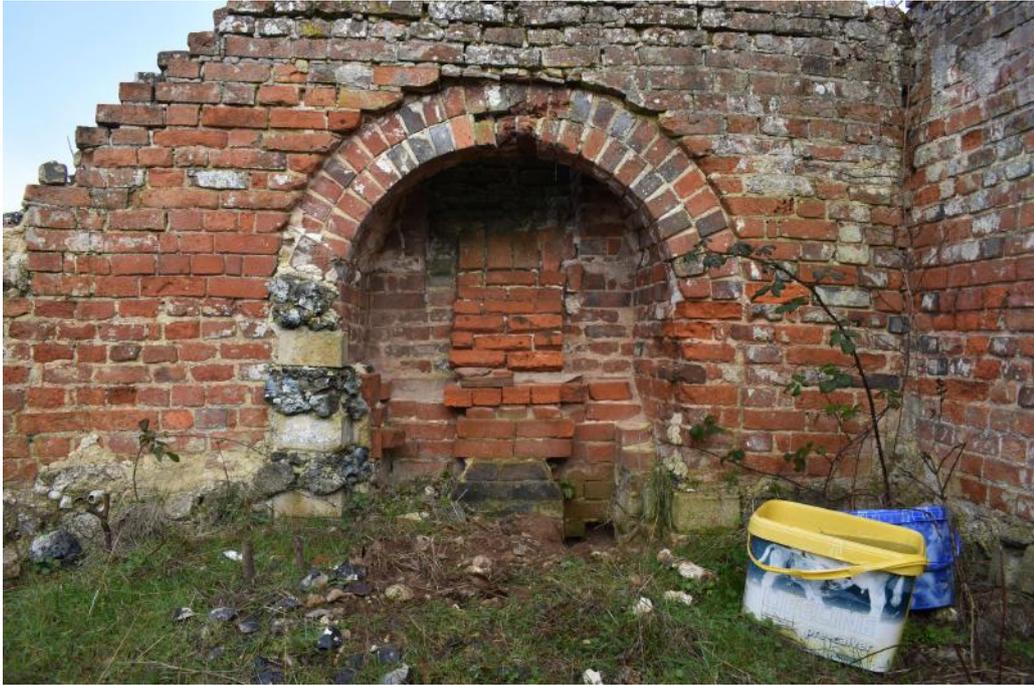
There are two fireplaces in Shell House, one on the northern wall (Photograph 15) and one on the southern (Photograph 16). Both have the remains of a carved stone and slag surround. The northern fireplace has slightly blackened lower bricks, evidence it may have used for a small fire at some point. The southern fireplace is decorative and is lined with a pink mortar with shells pressed in.

Photograph 15 Detail of fireplace in northern wall. Photograph taken facing north-east.

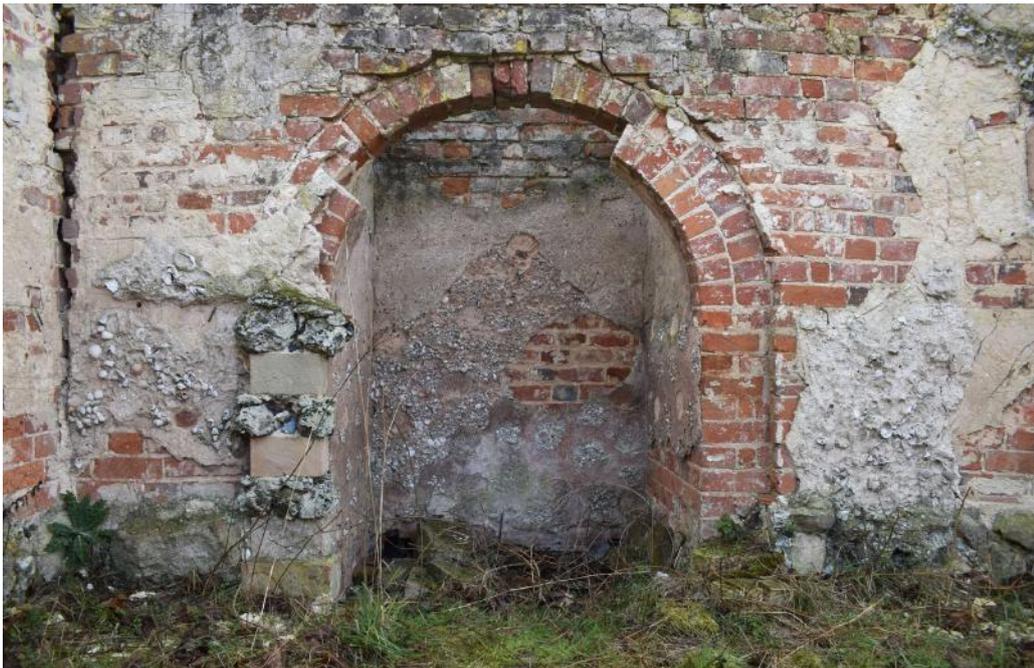
Photograph 16 Detail of fireplace in southern wall. Photograph taken facing south-west.

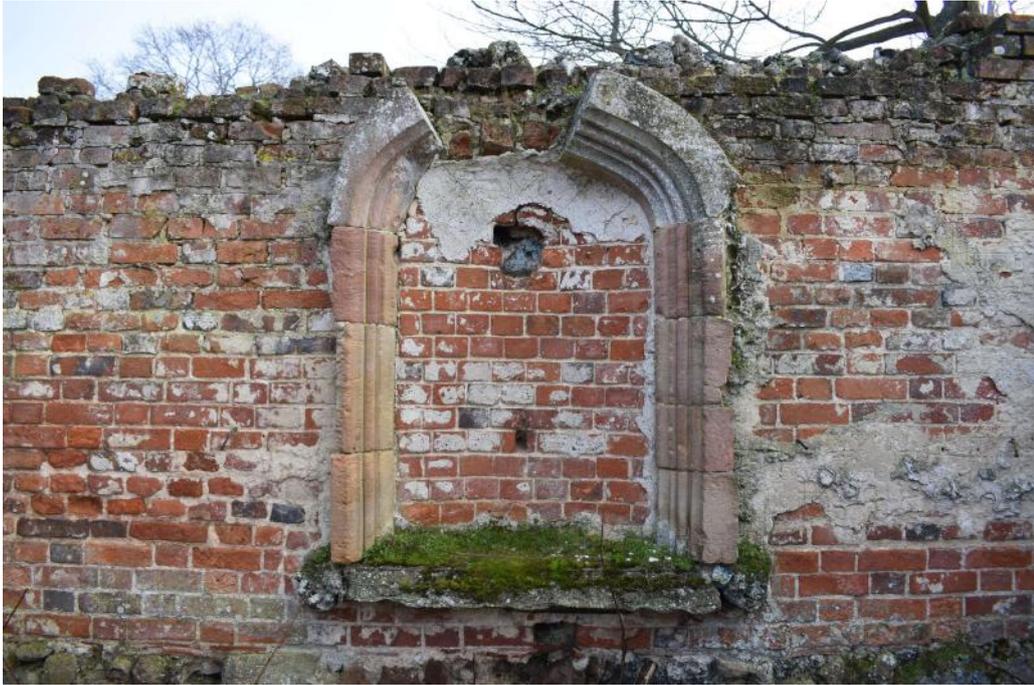
On the eastern wall is an alcove with a concrete sill and a carved stone surround (Photograph 17) The back of the alcove is constructed with half-bricks laid in header bond. A small amount of keyed mortar survives in the alcove.

Photograph 17 Detail of alcove in eastern wall. Photograph taken facing south-east.

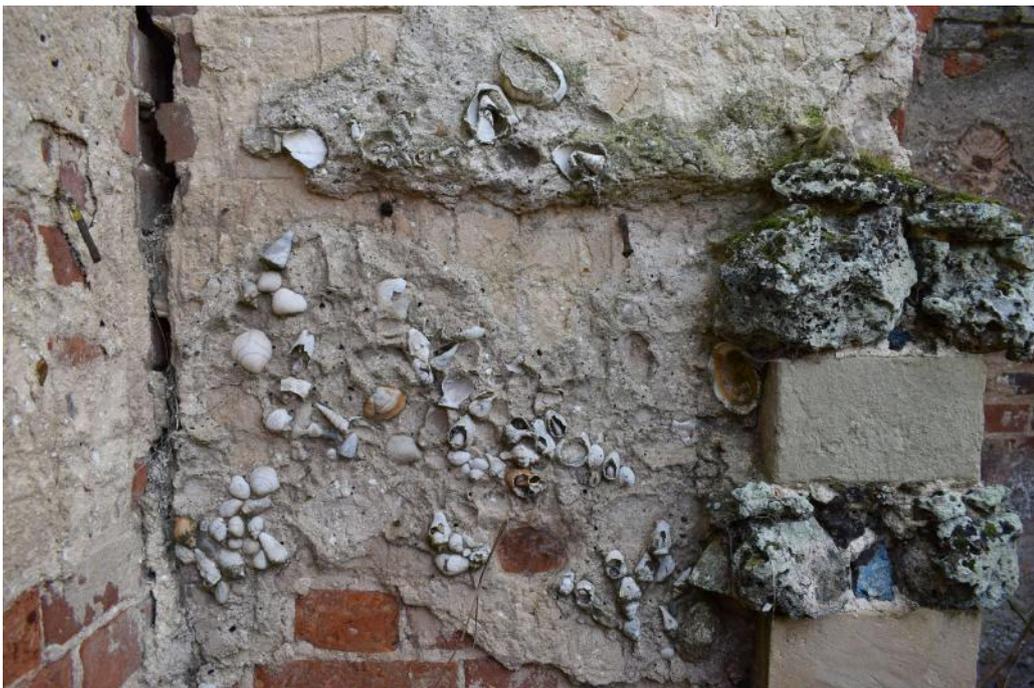
On the interior walls of the folly are patchy remains of a mortar skim with cross-hatched key marks. In some areas a secondary skim of mortar survives, into which shells have been pressed (Photograph 18).

Photograph 18 Detail of shells in plaster on southern wall. Photograph taken facing south-west.

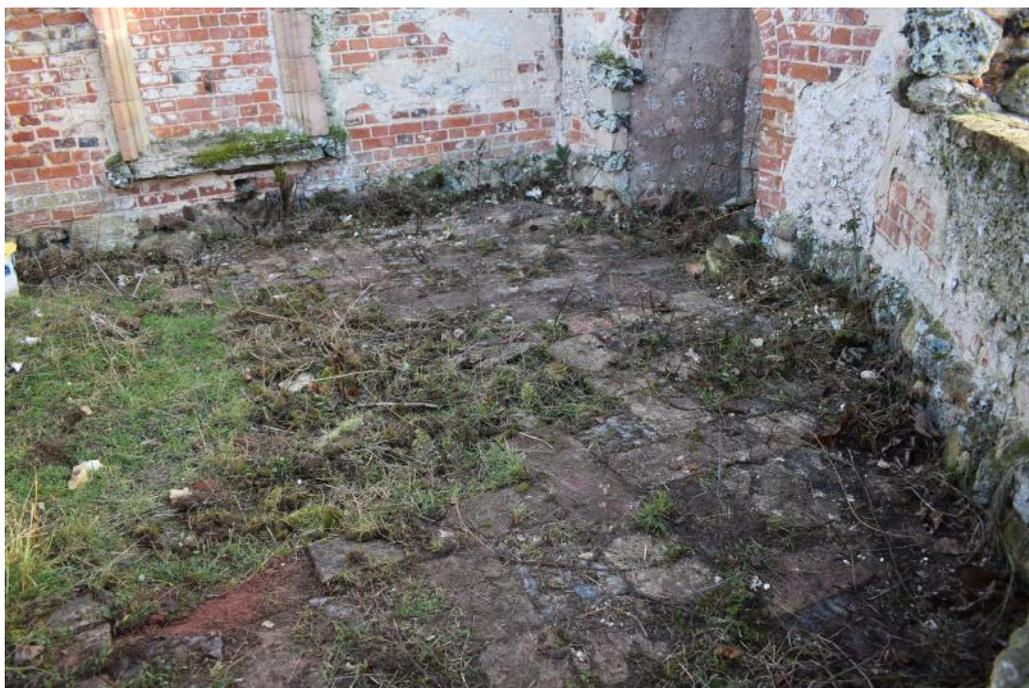
Roughly half of the floor remains (Photograph 19). It is constructed from a combination of different shaped floor bricks surrounding areas of knapped flint.

Photograph 19 Detail of floor. Photograph taken facing south-east.

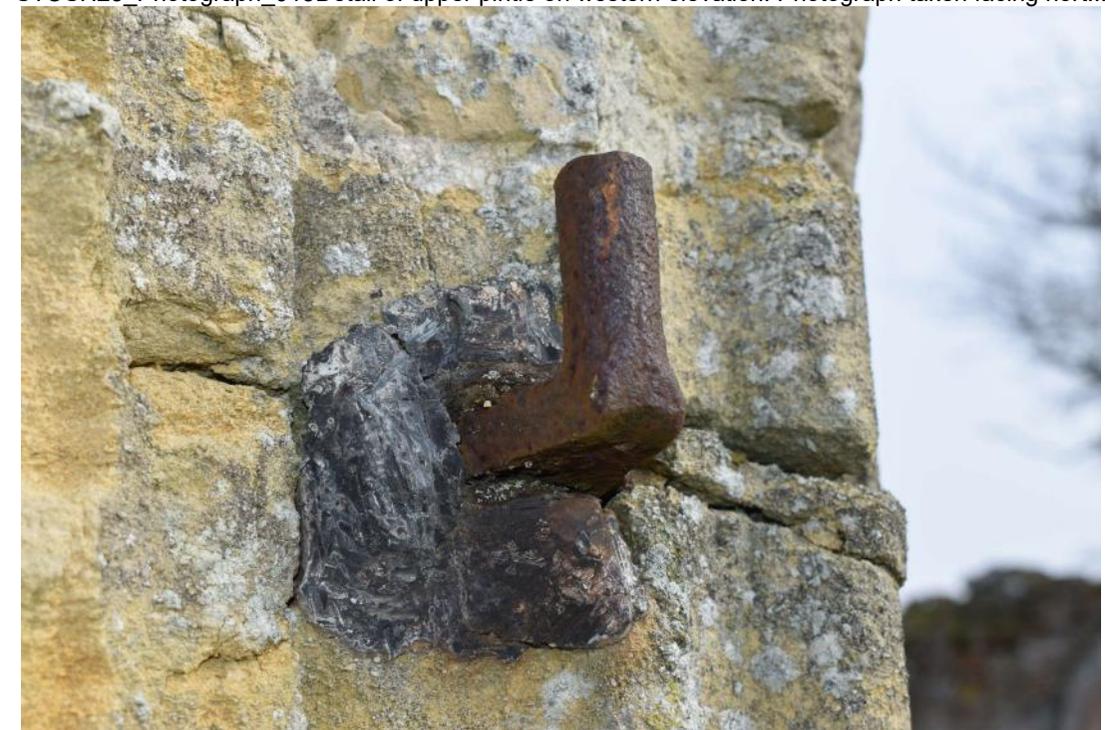
STOSH23_Photograph_015Detail of upper pintle on western elevation. Photograph taken facing nort... STOSH23_Photograph_016Detail of lower pintle on western elevation. Photograph taken facing north...

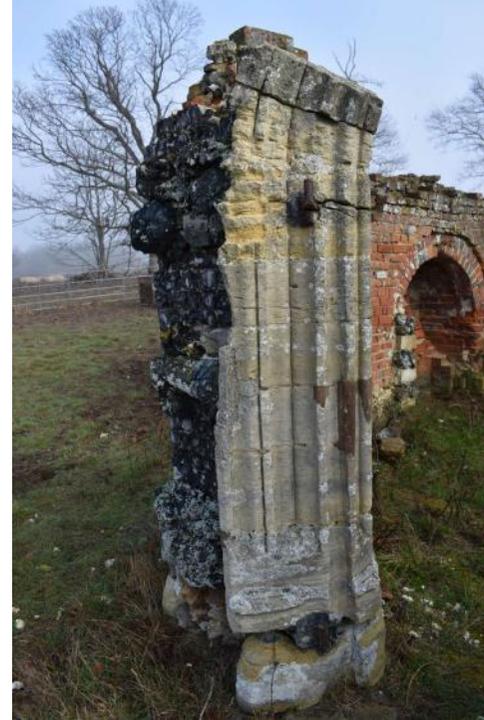
STOSH23_Photograph_019Detail of southern side of doorframe on western elevation. Photograph ta...

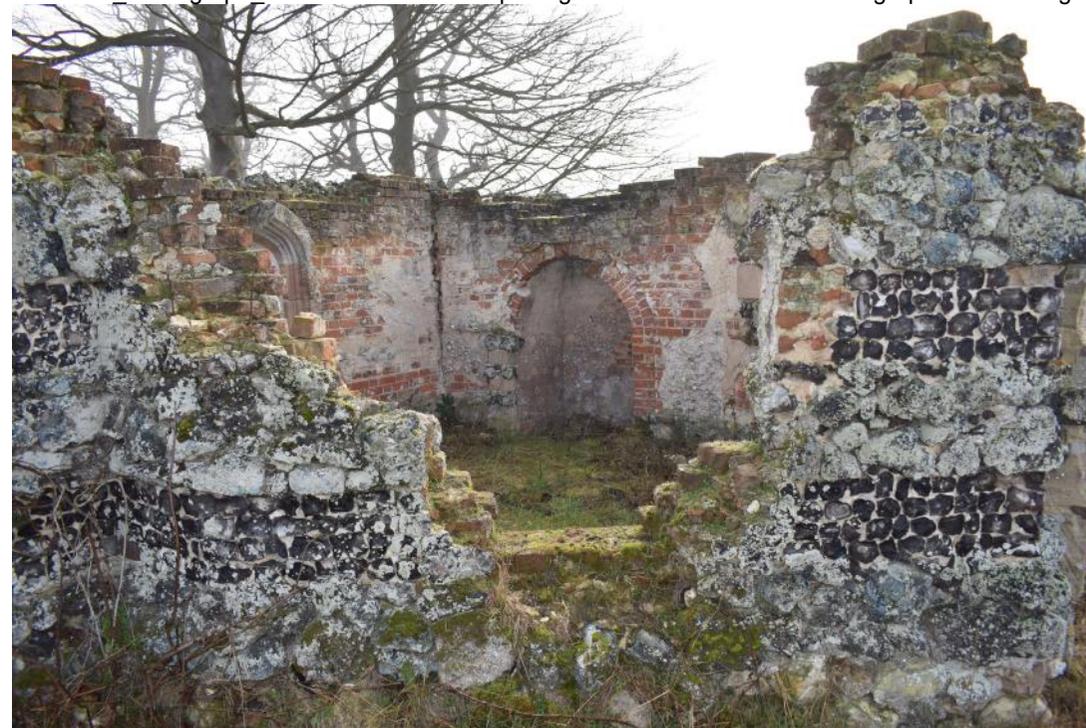
STOSH23_Photograph_021Detail of window opening in northern elevation with scale. Photograph taken facing north.

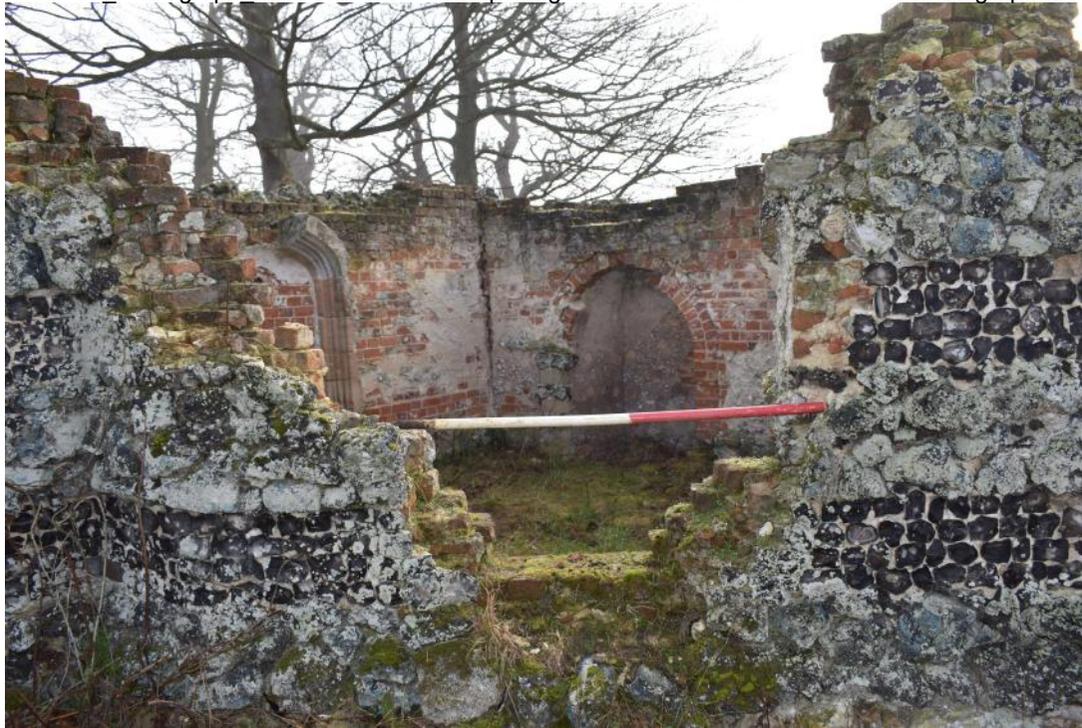
STOSH23_Photograph_022Detail of window opening in the southern elevation. Photograph taken facing south.

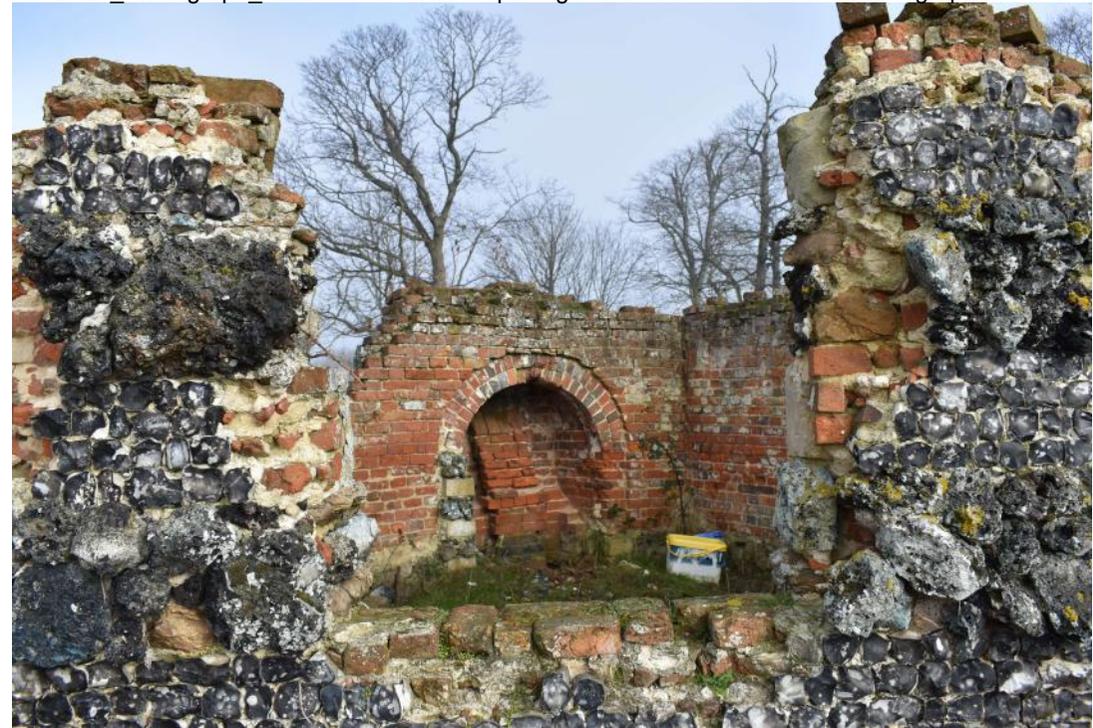
STOSH23_Photograph_023Detail of window opening in the southern elevation with scale. Photograph taken facing south.

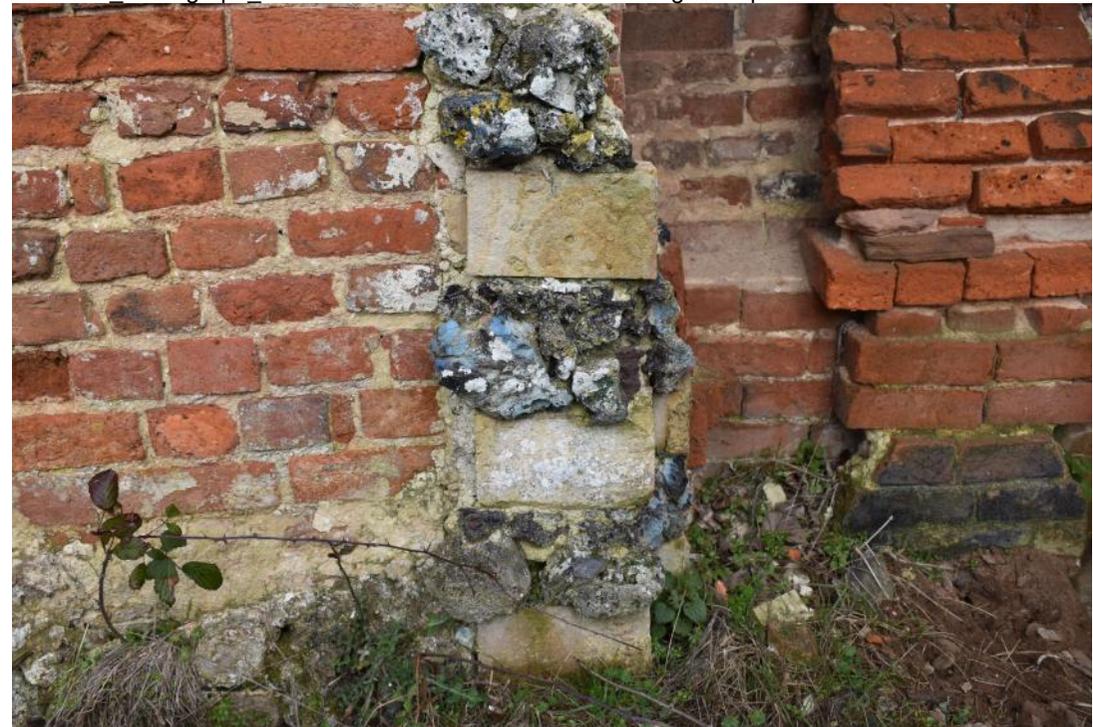
STOSH23_PhotoGraph_036Detail of carved stone and blue slag in fireplace surround on northern wal...

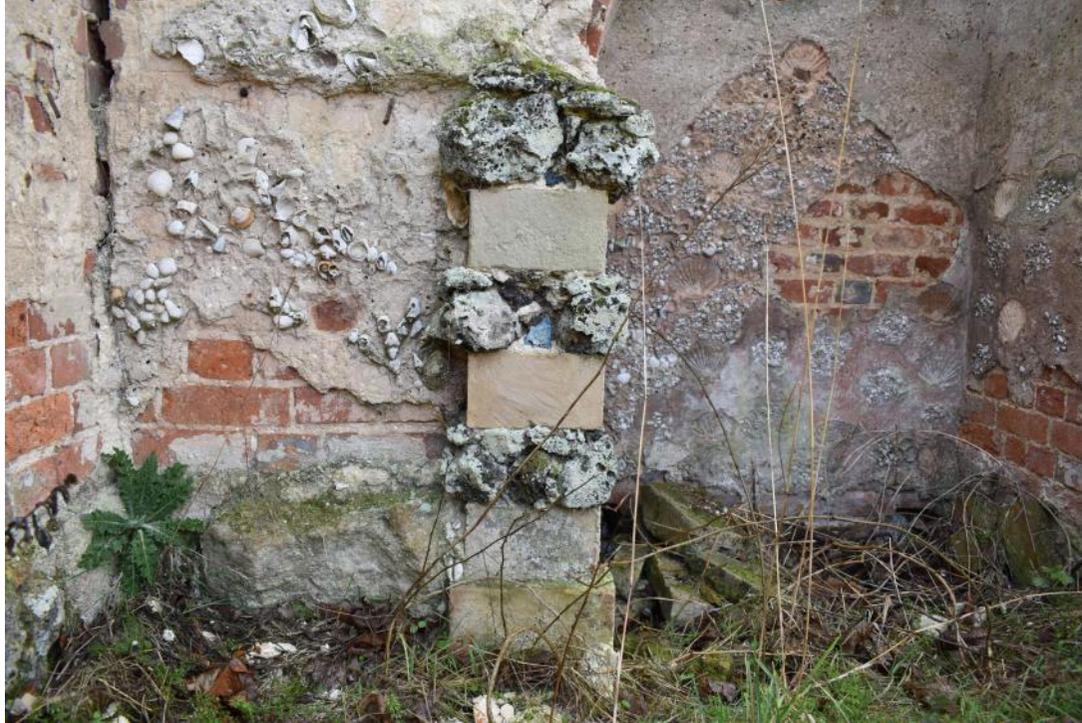
STOSH23 Photograph_041Detail of carved stone and blue slag in fireplace surround on south south-...

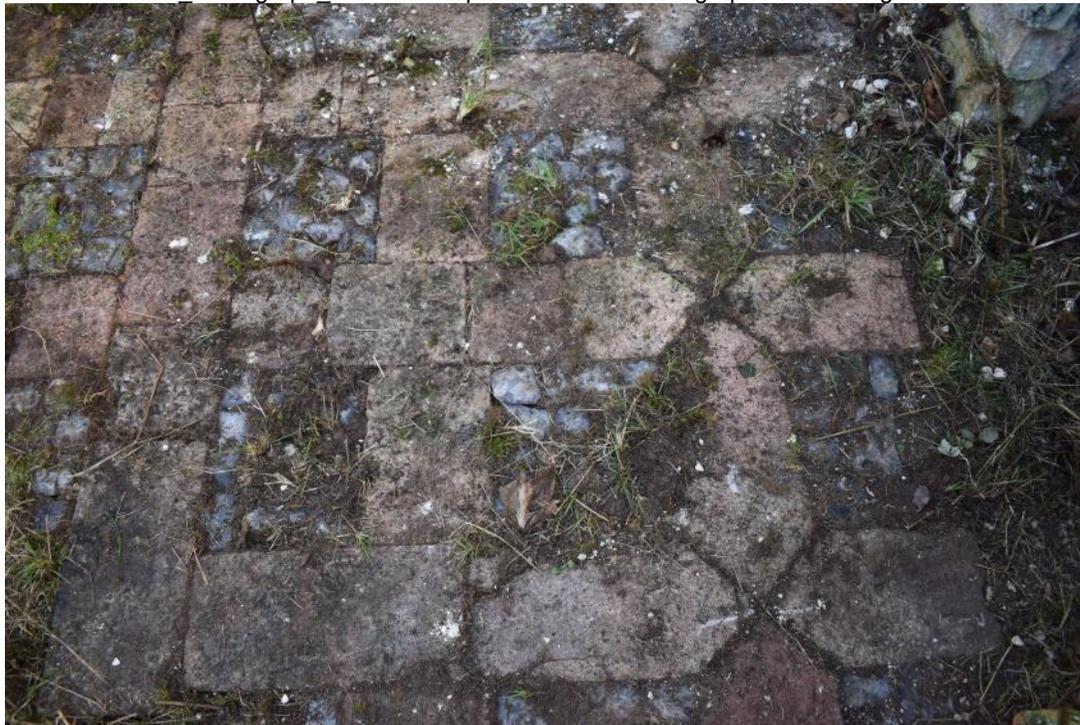
STOSH23 Photograph_055Detail of pattern in floor. Photograph taken facing south-east.

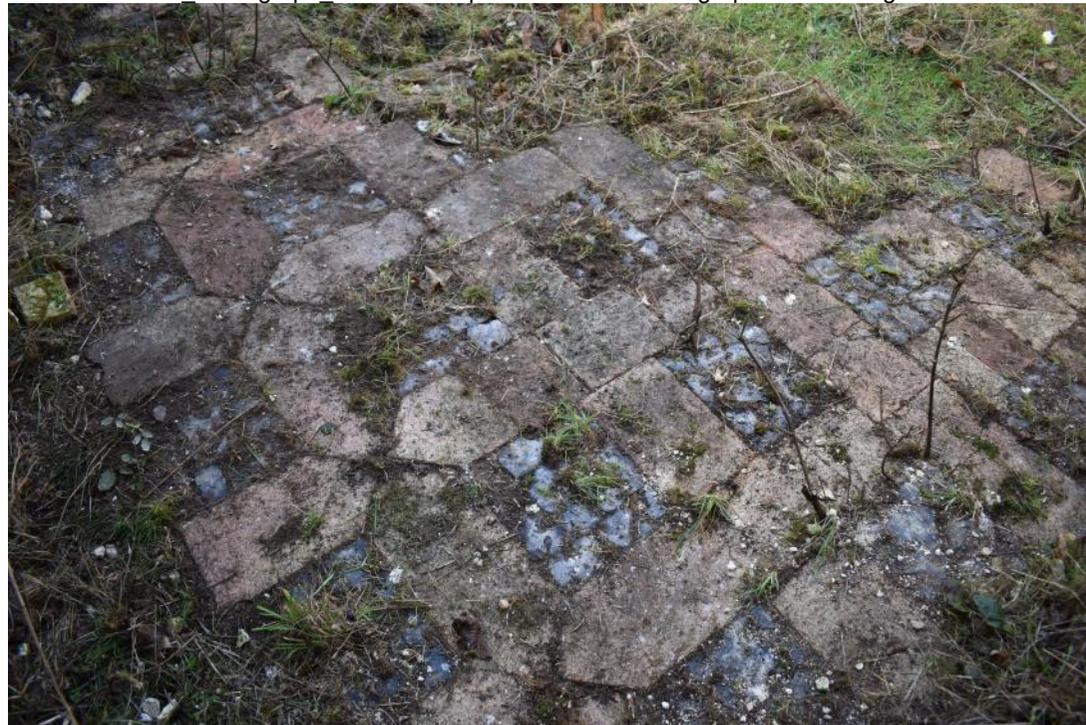
STOSH23 Photograph_056Detail of pattern in floor. Photograph taken facing north-west.

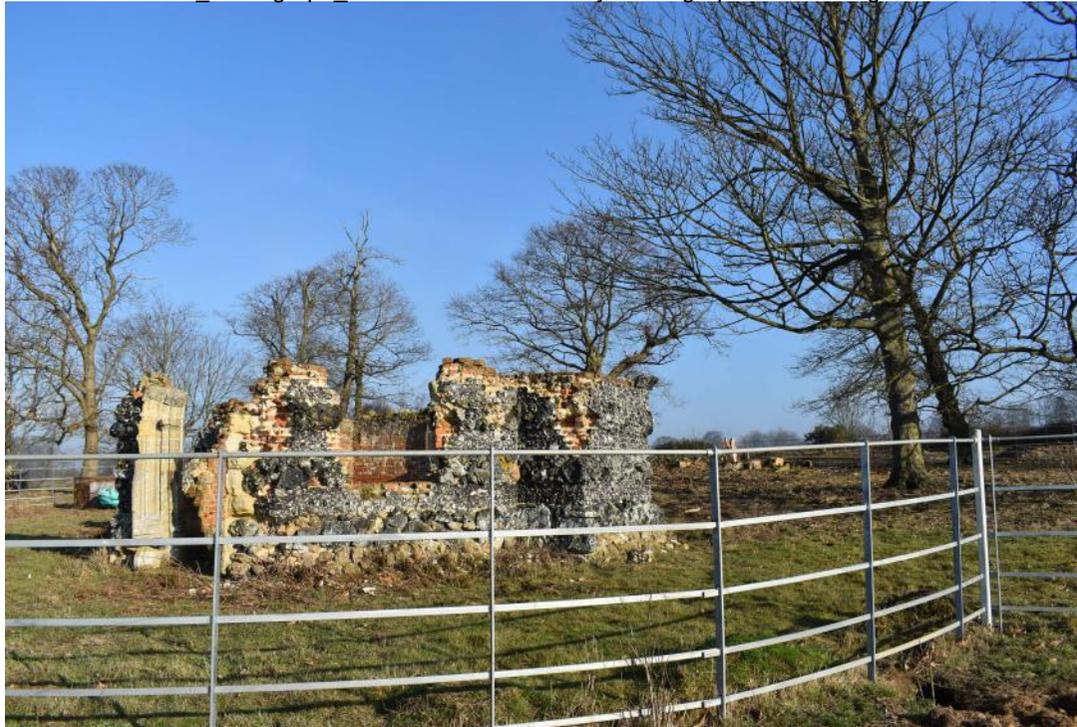
STOSH23_PhotoGraph_057Location shot of folly. Photograph taken facing north-east.

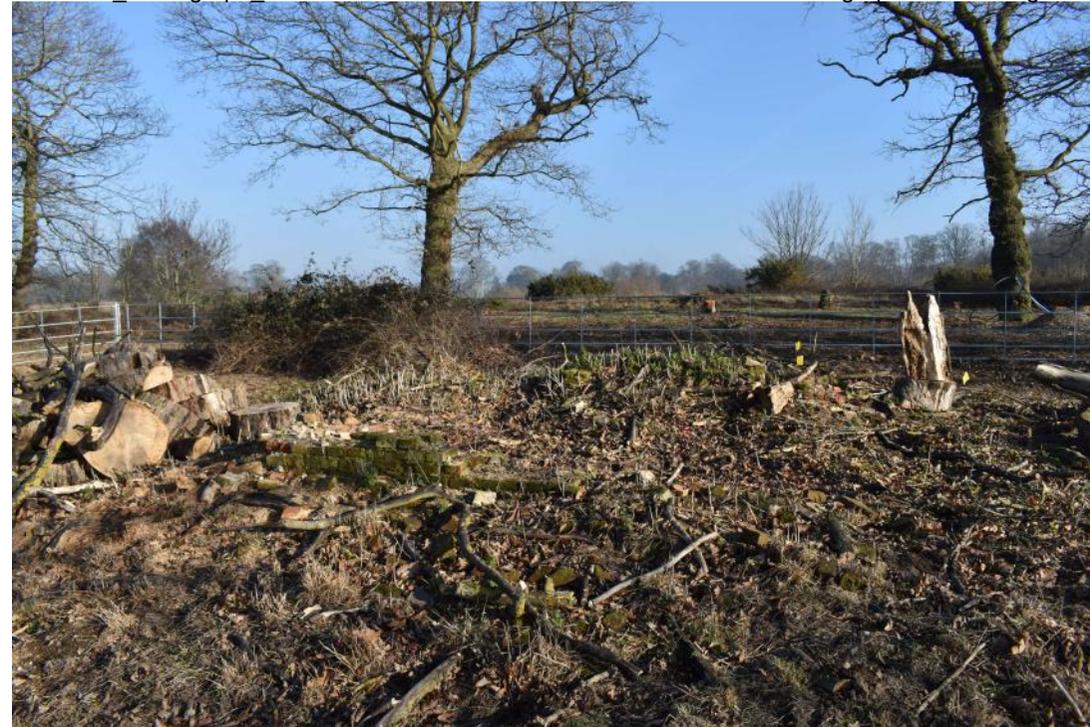
STOSH23_PhotoGraph_058Brick foundations to the east of shell house. Photograph taken facing east.

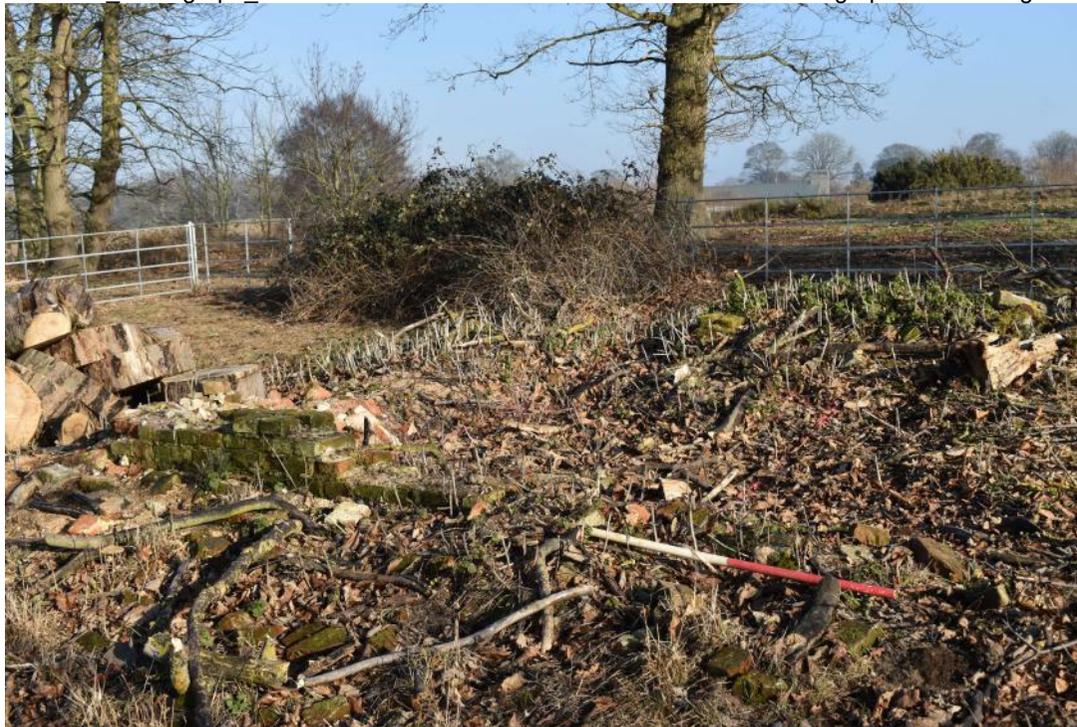
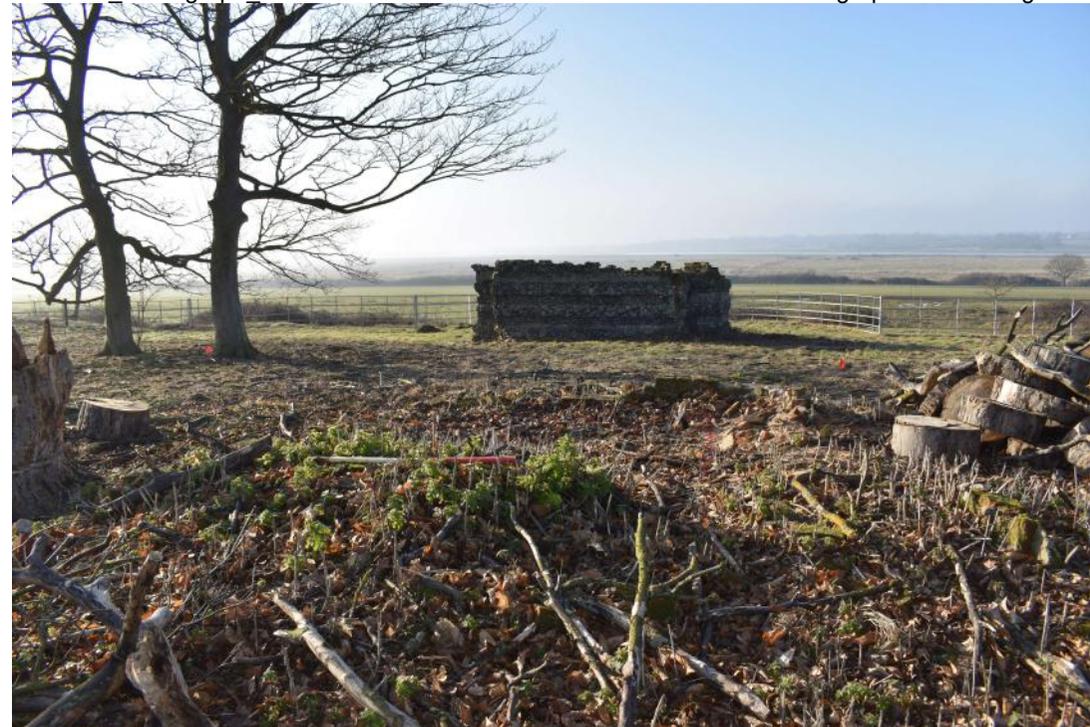
STOSH23_PhotoGraph_059Brick foundations to the east of shell house. Photograph taken facing east. STOSH23_PhotoGraph_060Brick foundations in relation to Shell House. Photograph taken facing north...

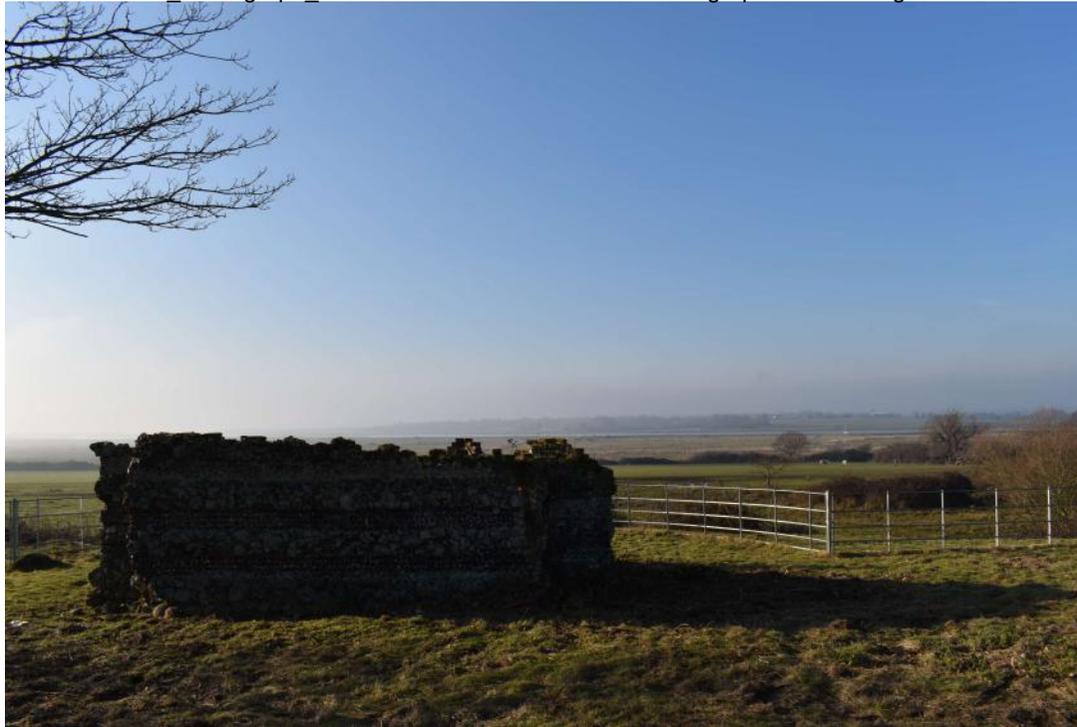
STOSH23_Photograph_061Shell House location shot. Photograph taken facing north-west.

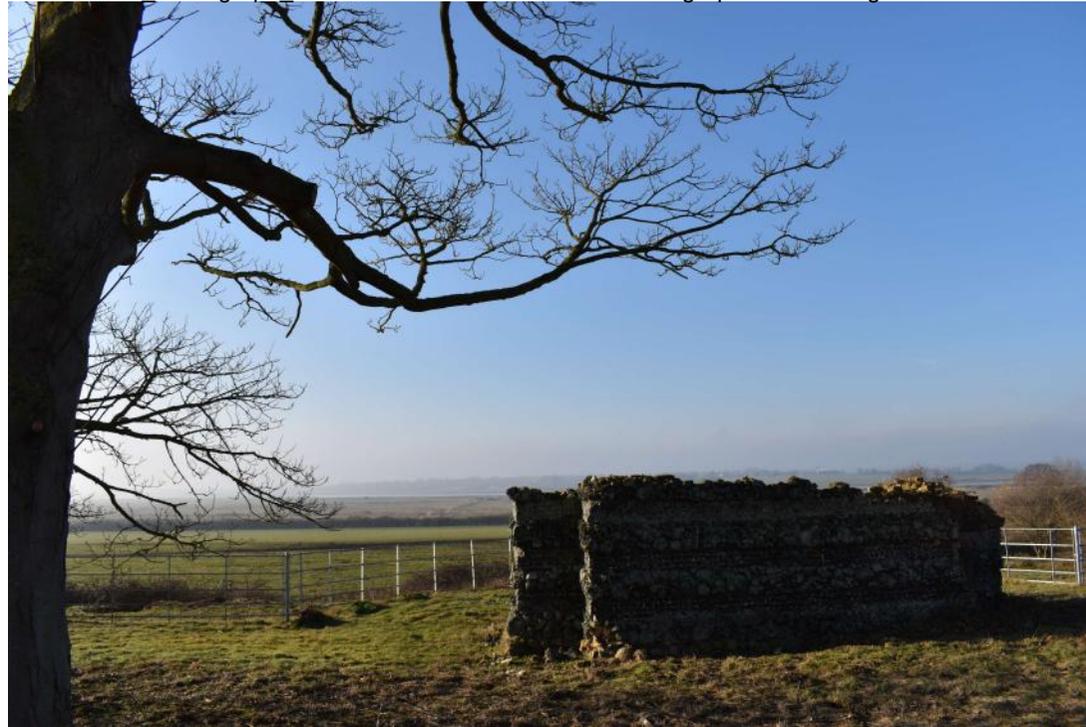
STOSH23_Photograph_062Shell House location shot. Photograph taken facing west north-west.

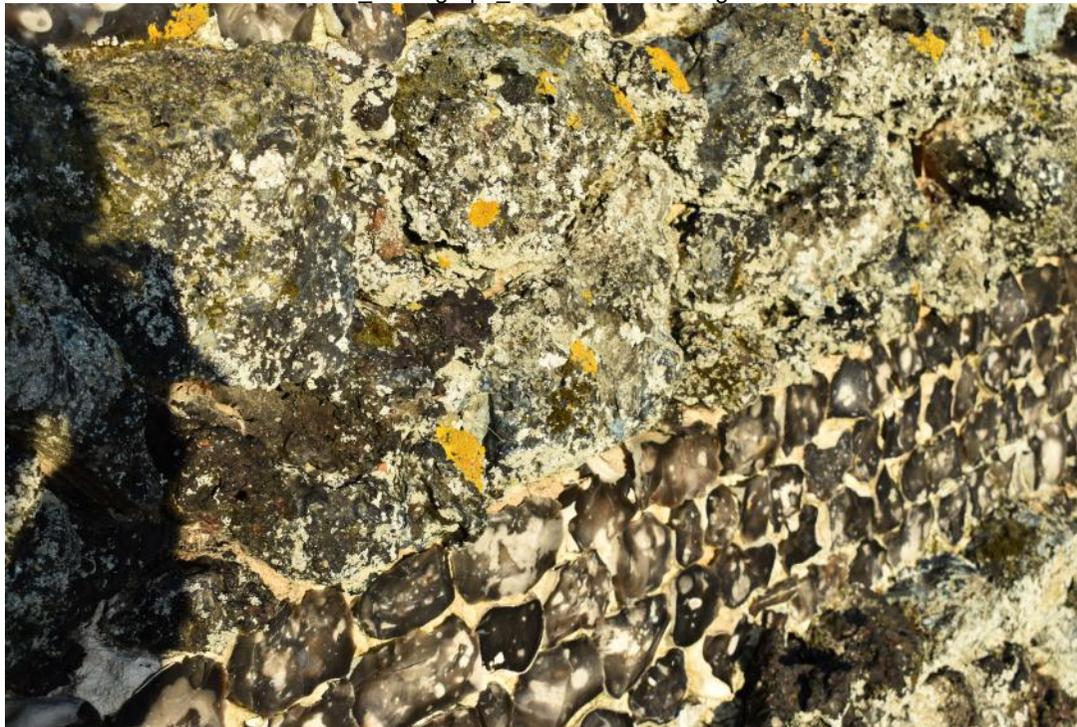
STOSH23_Photograph_063Detail of building materials.

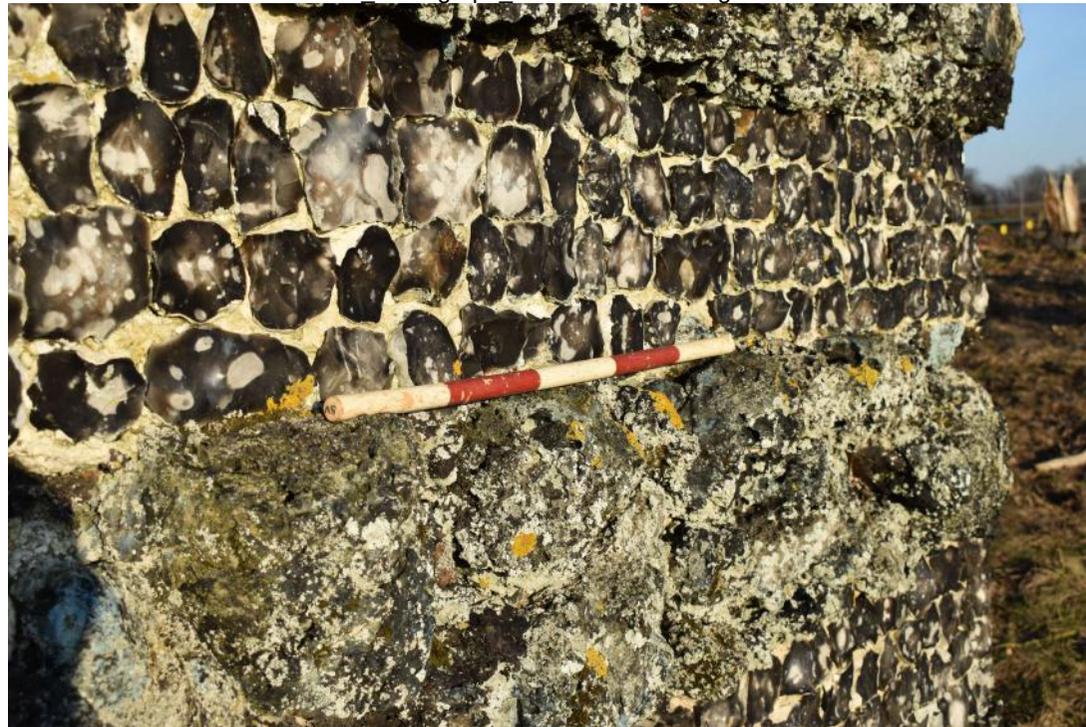
STOSH23_Photograph_064Detail of building materials.
