CAT Report 1938
issued June 2023

**Historic building recording of outbuildings at 111
Newland Street, Witham, Essex, CM8 1BG**

CAT project ref.: 2023/04d
ECC code: WH28

**Planning ref.: 20/00808/FUL
(Appeal reference: APP/Z1510/W22/3293210)**

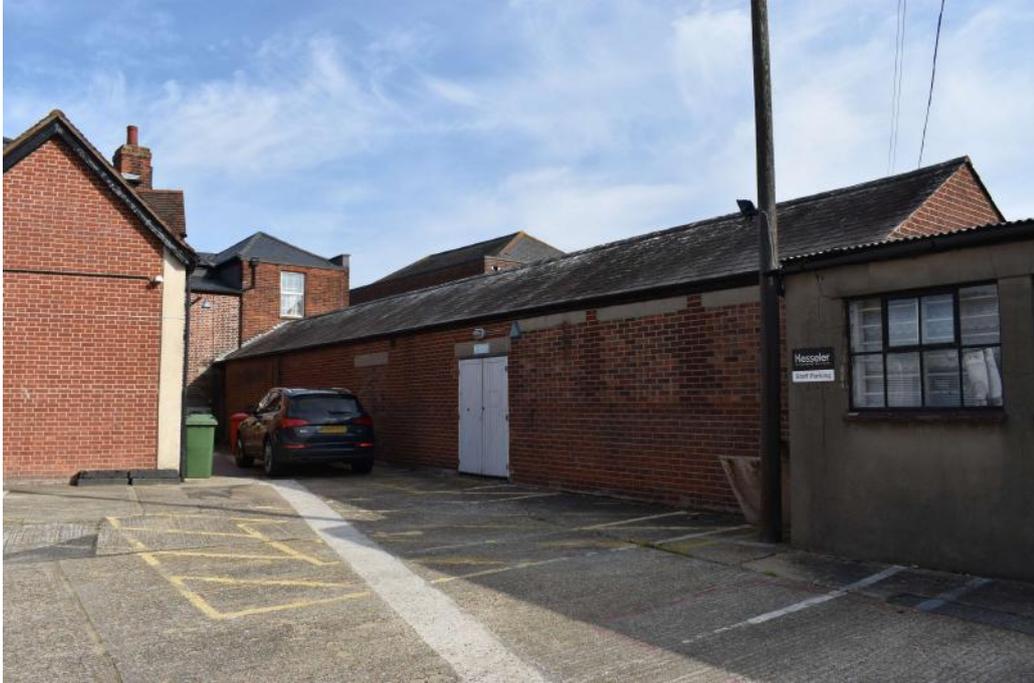
Photograph 1 South-west elevation of outbuilding 1. Photograph taken facing north.

Outbuilding 1 is constructed from red brick (brick dimensions: 225 x ? x 65mm) laid in stretcher bond, forming a cavity wall. The roof is gabled at both ends and clad in slate. There is a set of timber double doors, with a concrete lintel, on the south-west elevation (Photograph 1) and a boarded-up timber-framed window on the north-east elevation (Photograph 2). There are four blocked openings on the south-west elevation, evidenced by the presence of concrete lintels.

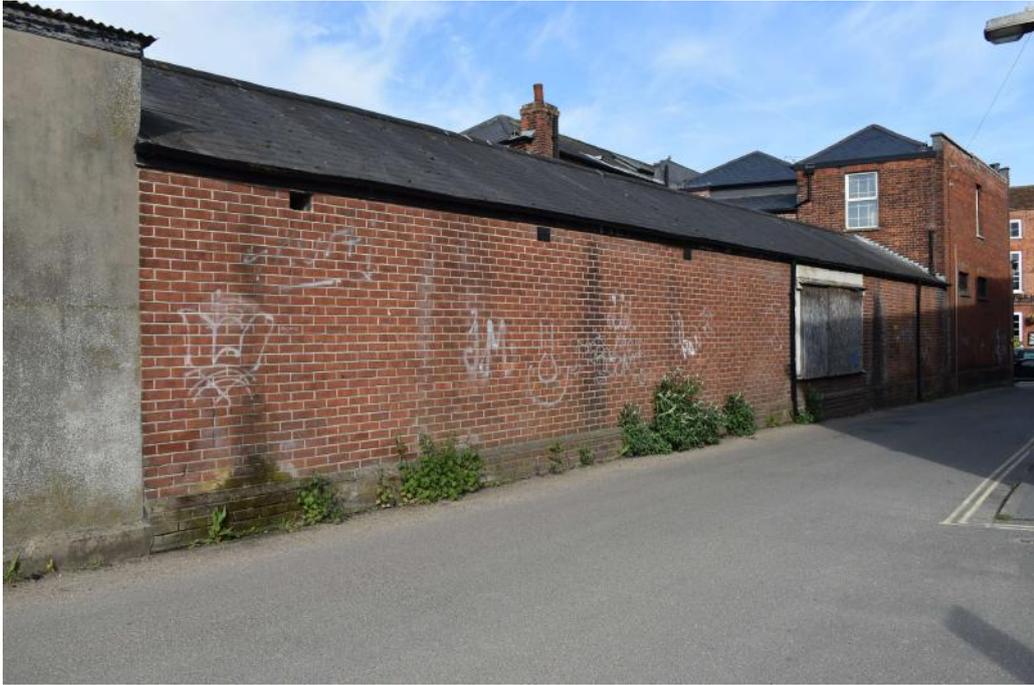
Photograph 2 North-east elevation of outbuilding 1. Photograph taken facing west.

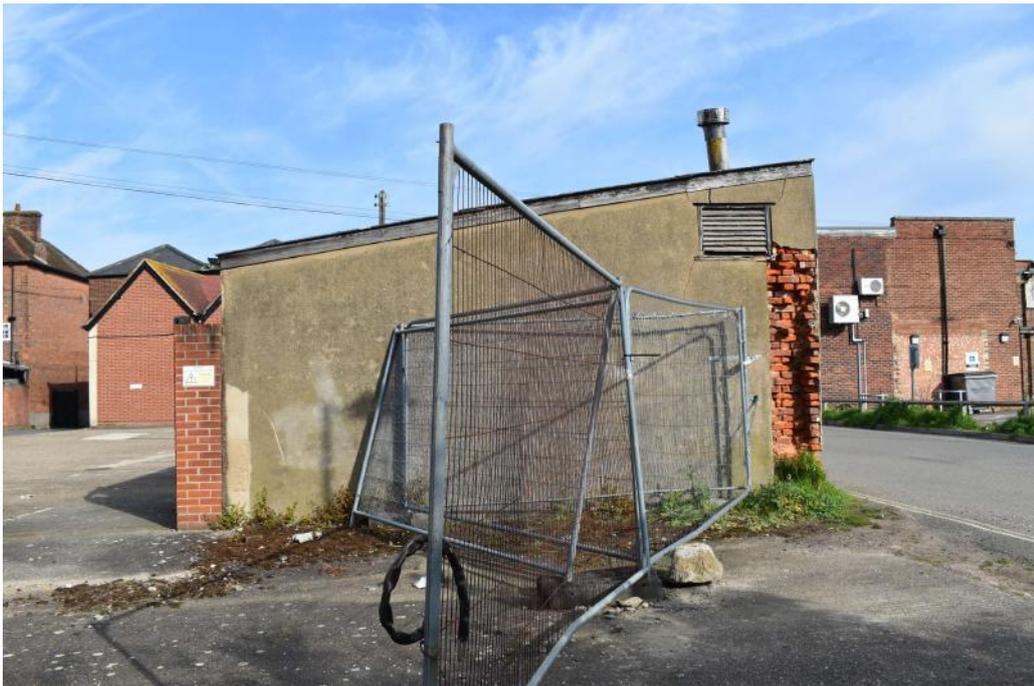
Photograph 5 South-east elevation of outbuilding 2. Photograph taken facing north-west.

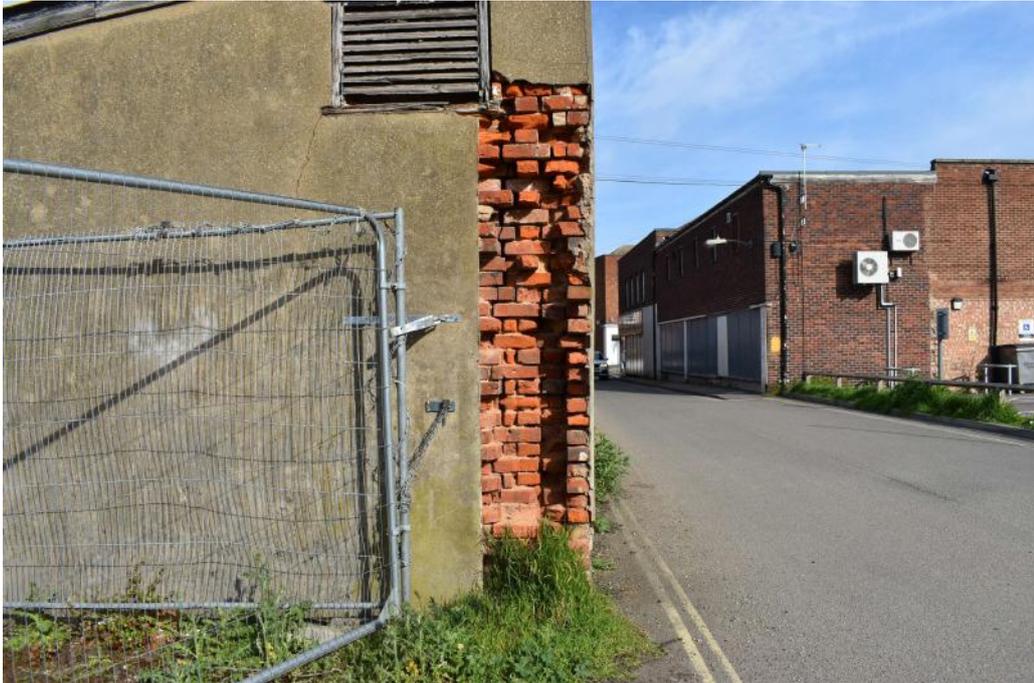
Outbuilding 2 has a concrete render on all elevations. Areas of damage to the render has revealed the brickwork beneath (Photograph 6) – red brick (brick dimensions: 220 x 105 x 60mm) laid in Monk bond. The roof is mono-pitched, sloping to the south-west, and clad in corrugated asbestos. There are two Crittall eight-light awning-windows (Photograph 4) and two blocked openings on the south-west elevation (Photograph 3). They all have concrete lintels. The south-east elevation (Photograph 5) has a timber louvre vent while the north-east elevation (Photograph 7) is plain render with small areas of damage.

Photograph 6 Detail of exposed brickwork on south-east elevation of outbuilding 2. Photograph taken facing north-west.

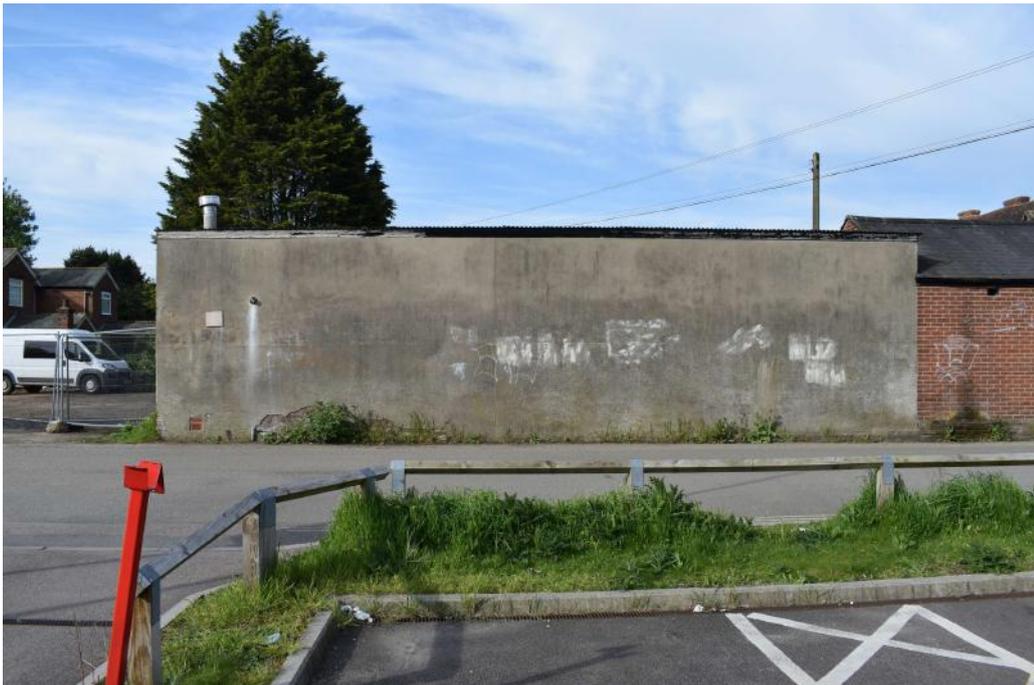
Photograph 7 North-east elevation of outbuilding 2. Photograph taken facing south-west.

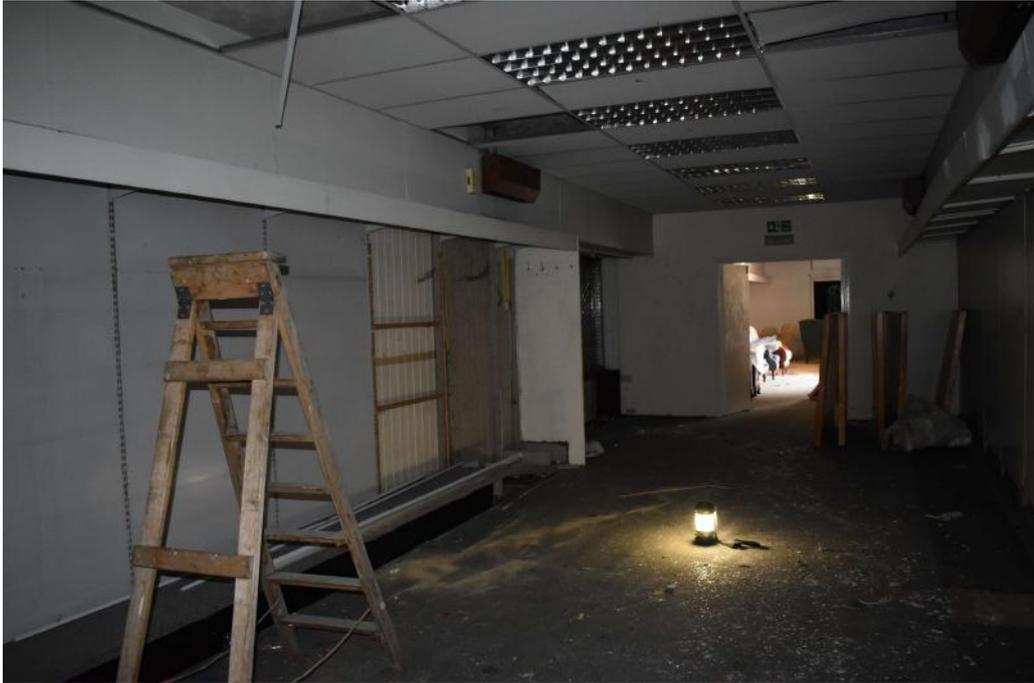
Rooms 1 and 2 (Photographs 8 and 9) are located in outbuilding 1. Both are carpeted and have plasterboard walls. The dividing wall between the two rooms is inserted with a set of double doors. In room 1, there is a blocked opening with steps down in the north-west wall and a two-light fixed window in the north-east wall. In room 2 there is a

Photograph 8 Interior of room 1. Photograph taken facing east.

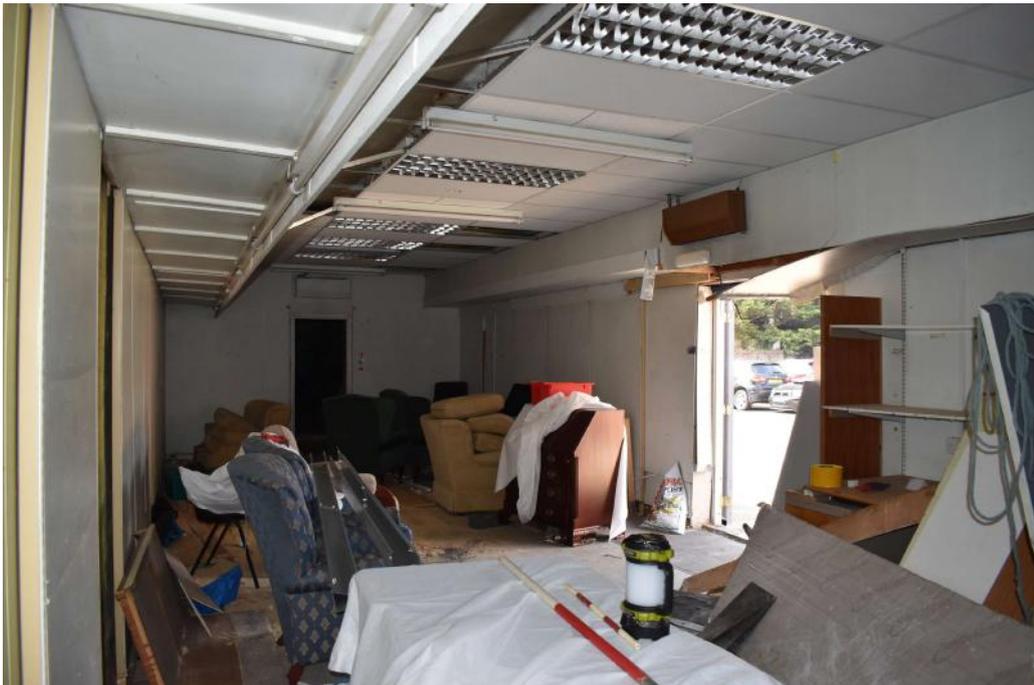
Photograph 9 Interior of room 2. Photograph taken facing south.

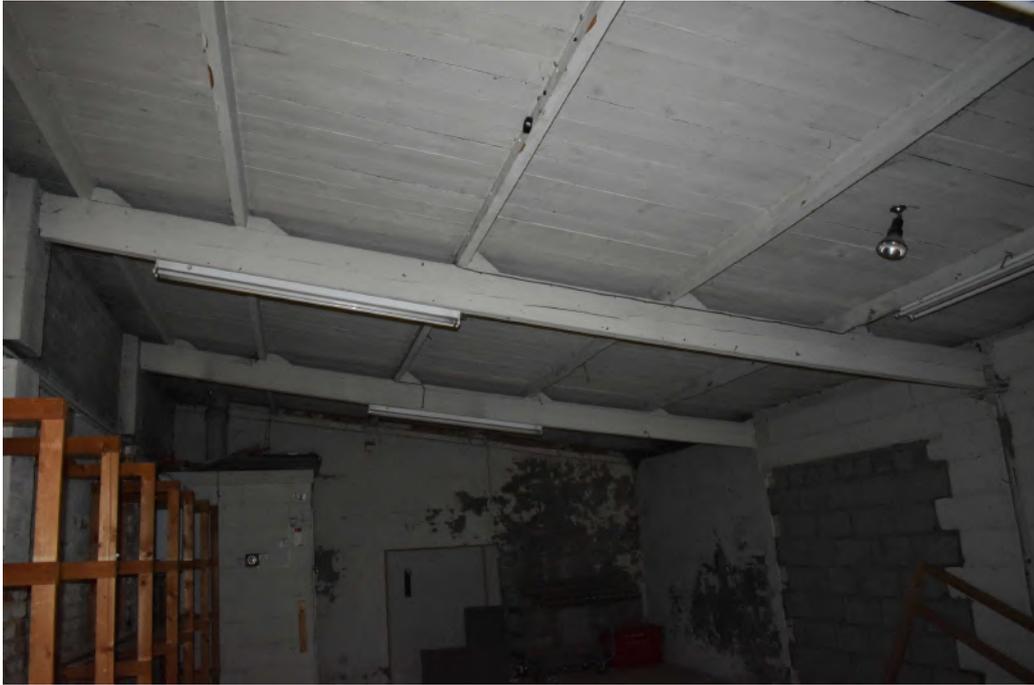
The roof of outbuilding 2 (Photograph 10) is constructed from single rafters that rise to meet a series of engaged-columns on the north-east wall. Two of the rafters are supported on iron posts on the south-west wall (Photograph 11), while the eastern rises from the wall. There are five purlins supported by the rafters. Each purlin has a splayed scarf joint and is supported on each rafter by a cleat.

Photograph 10 Detail of outbuilding 2 roof construction. Photograph taken facing south-east.

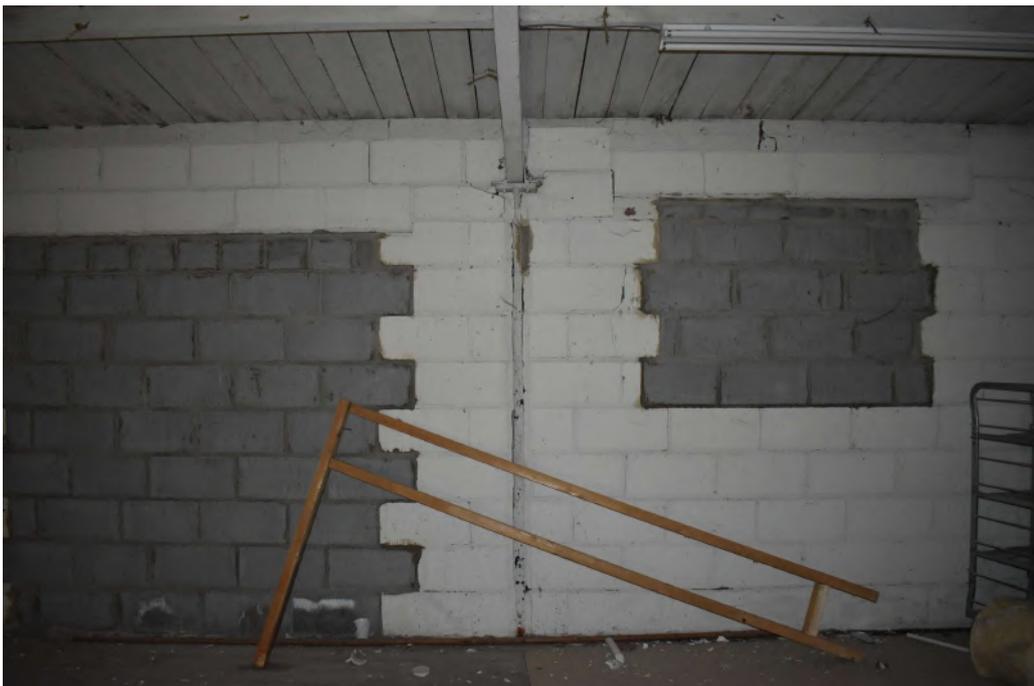
Photograph 11 Detail of iron post in south-west wall of outbuilding 2. Photograph taken facing south-west.

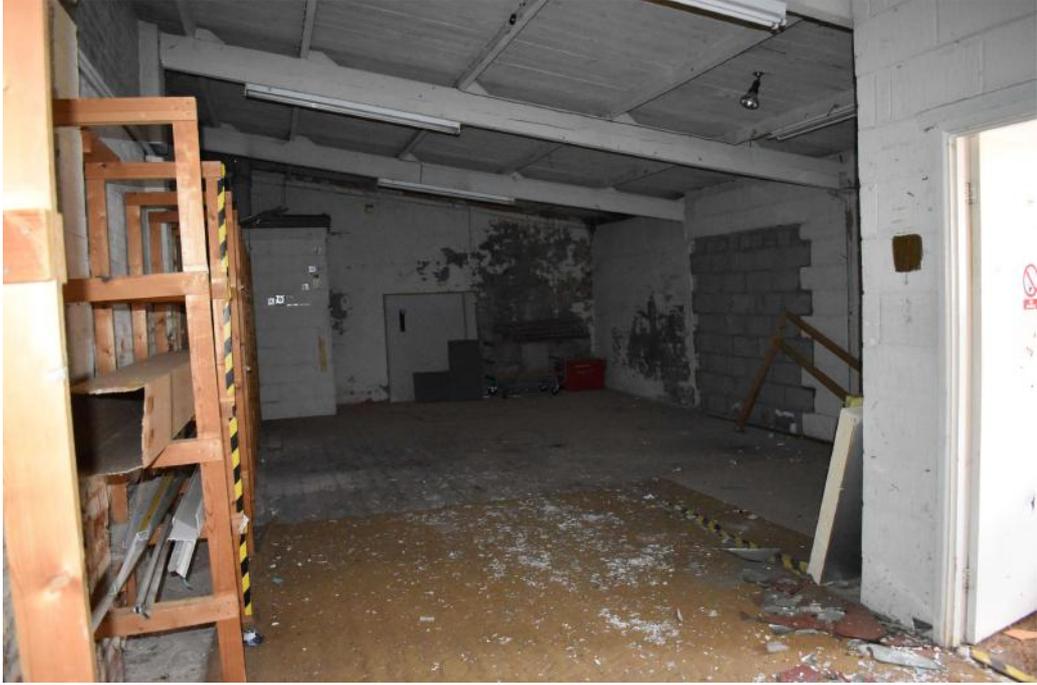
There are two blocked openings in the south-western wall of room 3 and two inserted rooms constructed from breeze blocks – one in the eastern corner (room 4) and one in western corner (inaccessible). The walls of room 4 are plastered and painted white. There are two Crittall windows in the south-west wall.

Photograph 12 Interior of room 3. Photograph taken facing south.

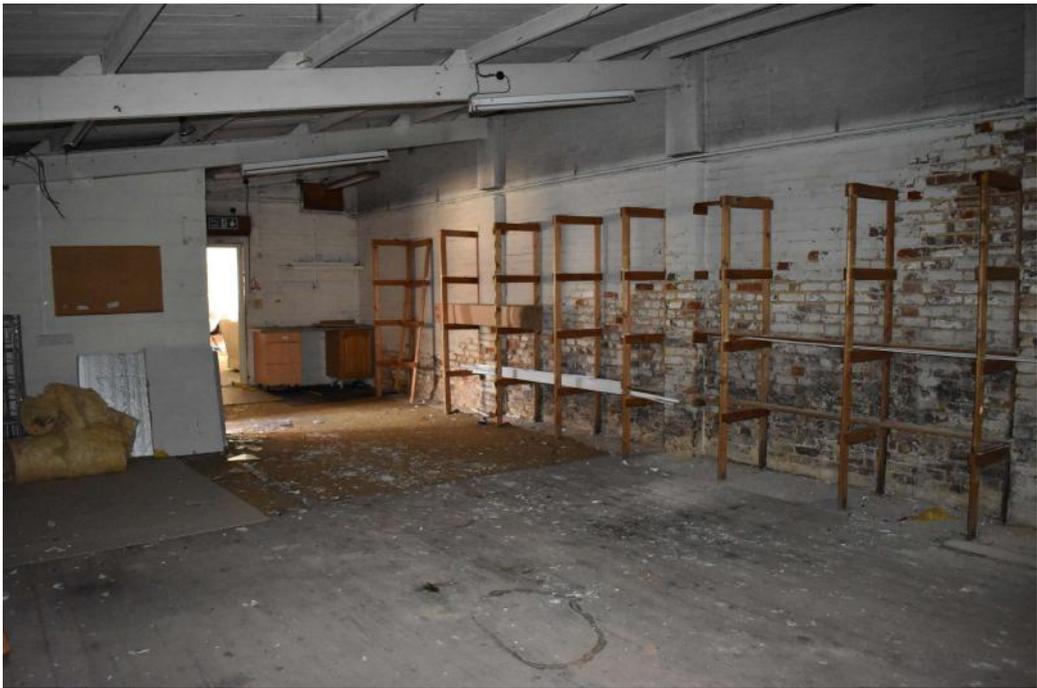
Photograph 13 Interior of room 3. Photograph taken facing north.

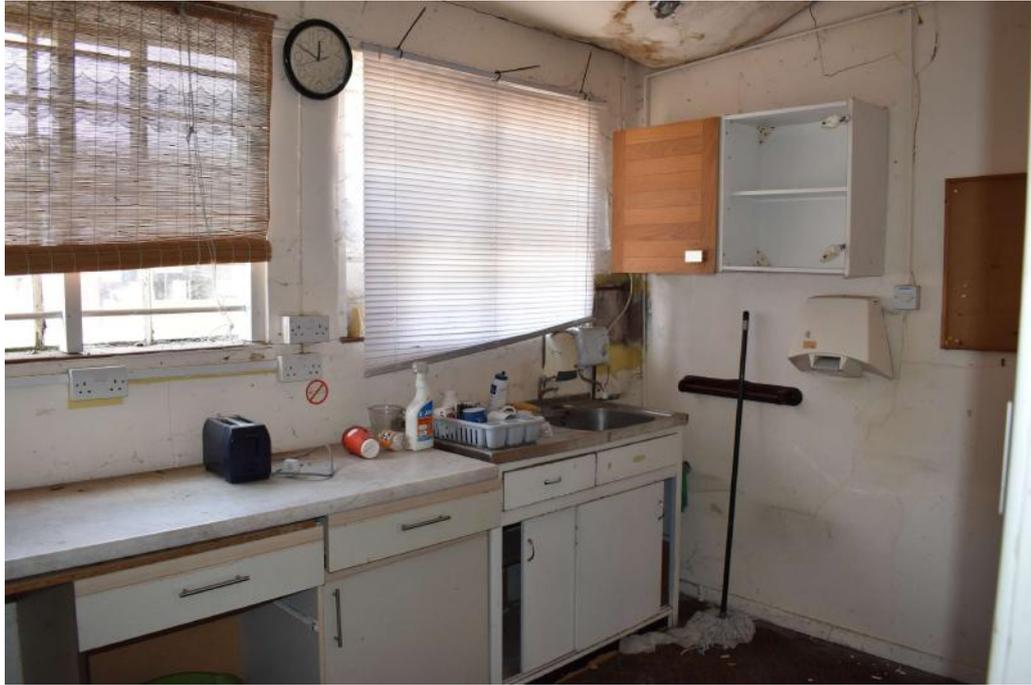
Photograph 14 Interior of room 4. Photograph taken facing west.
