**CAT Report 1975  
issued October 2023**

**Historic building recording of the stables at Great  
Graces, Graces Lane, Little Baddow, Essex,  
CM3 4AY**

**September 2023**

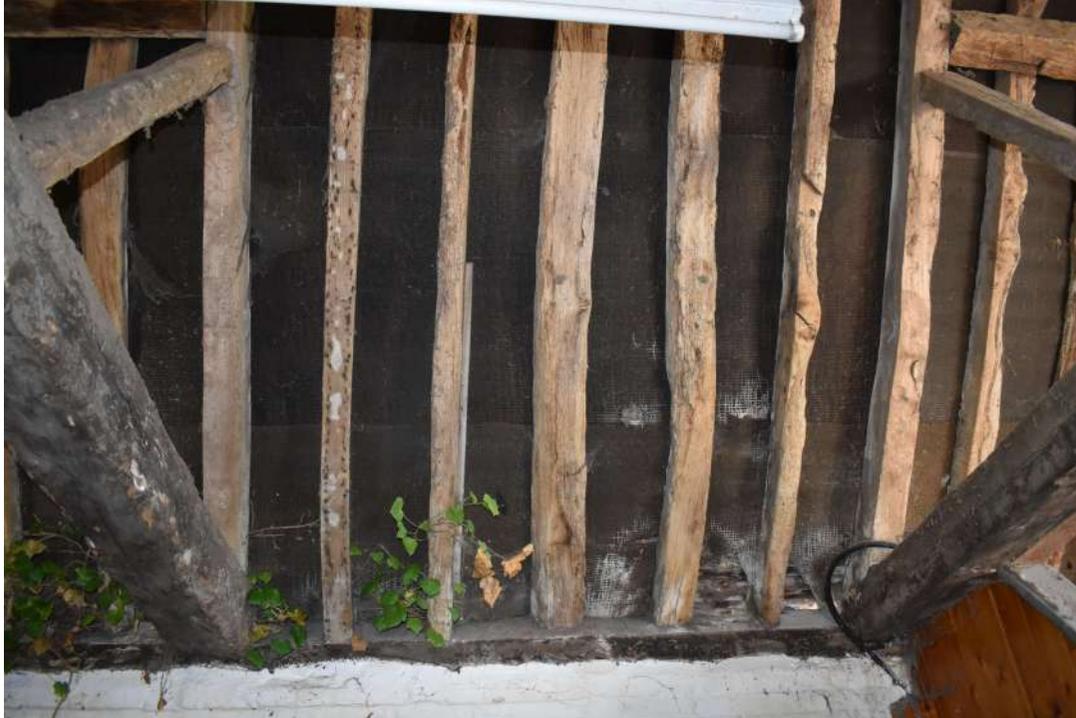
LBGG23 Photograph\_053Detail of roof structure, showing reused timbers, of western roof p...

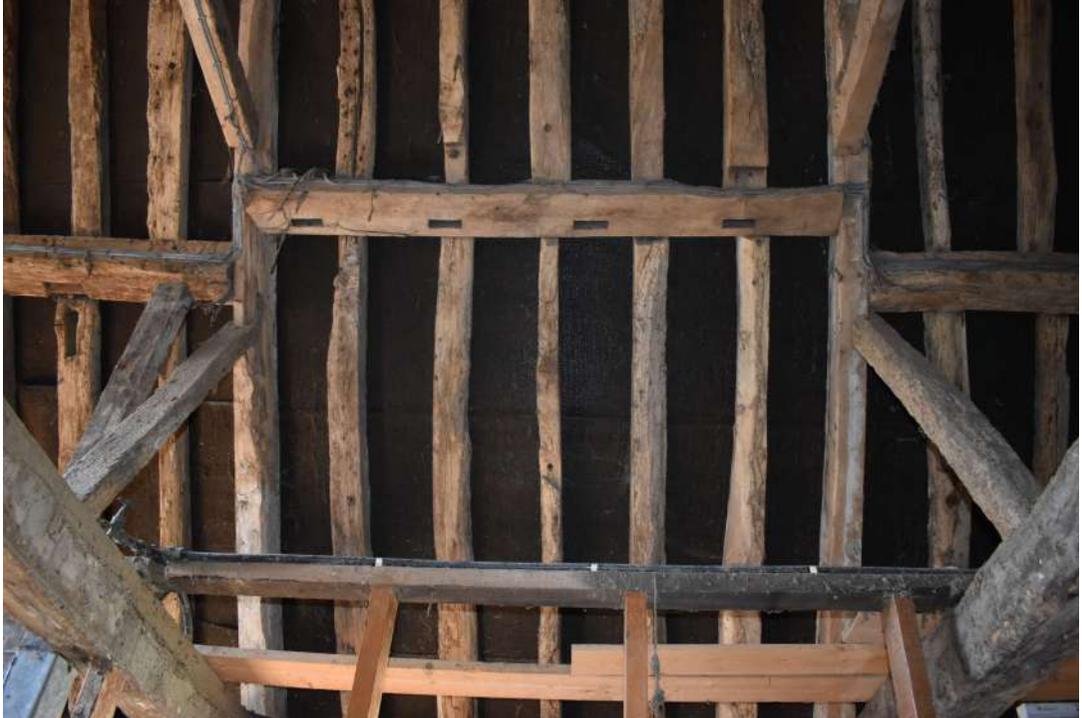
LBGG23 Photograph\_054Detail of knee-brace between bays 4 and 5 of stable 1. Photograph...

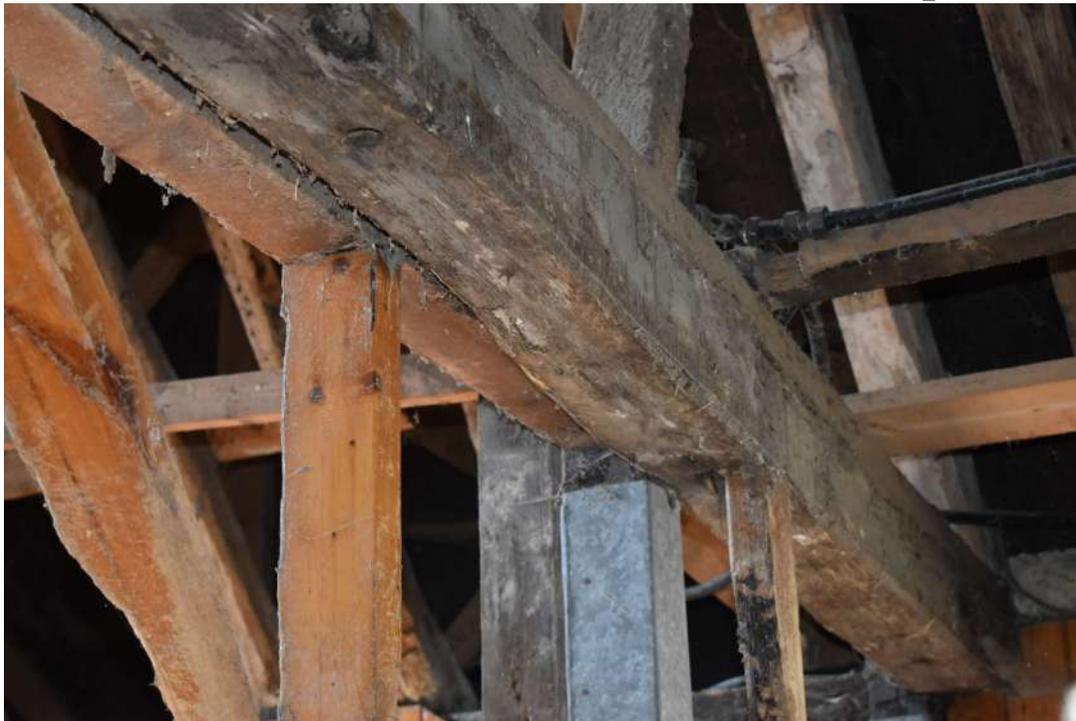
LBGG23\_Photograph\_055Detail of roof structure, showing reused timbers, of eastern roof p...

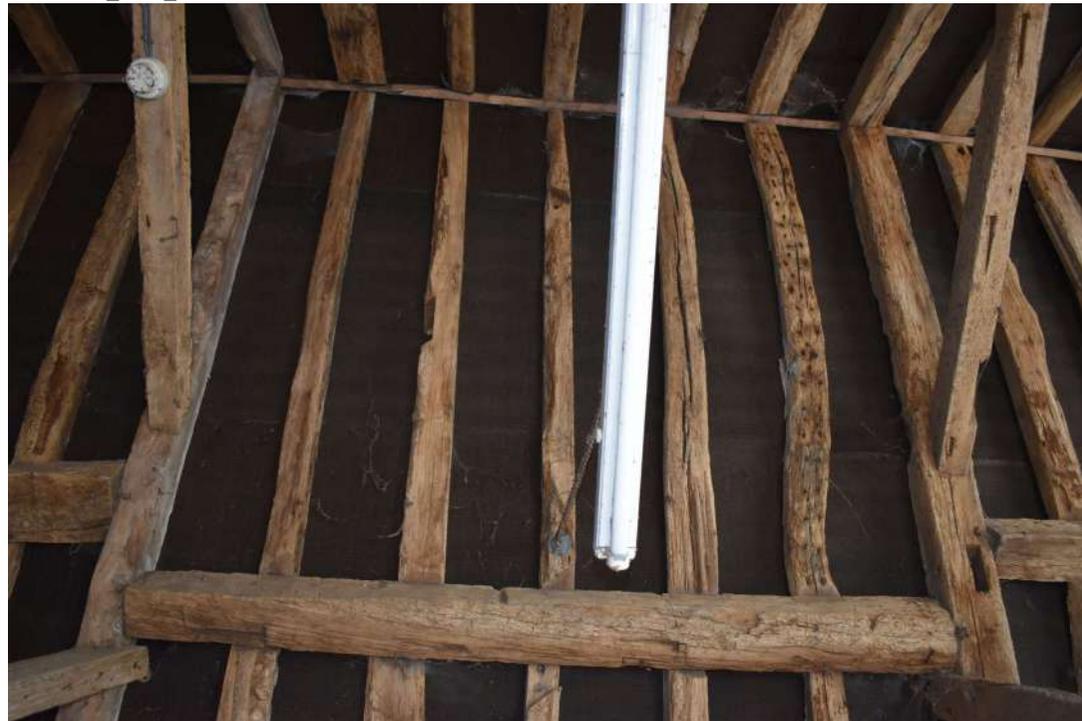
LBGG23\_Photograph\_056Detail of roof structure, showing reused timbers, of western roof p...

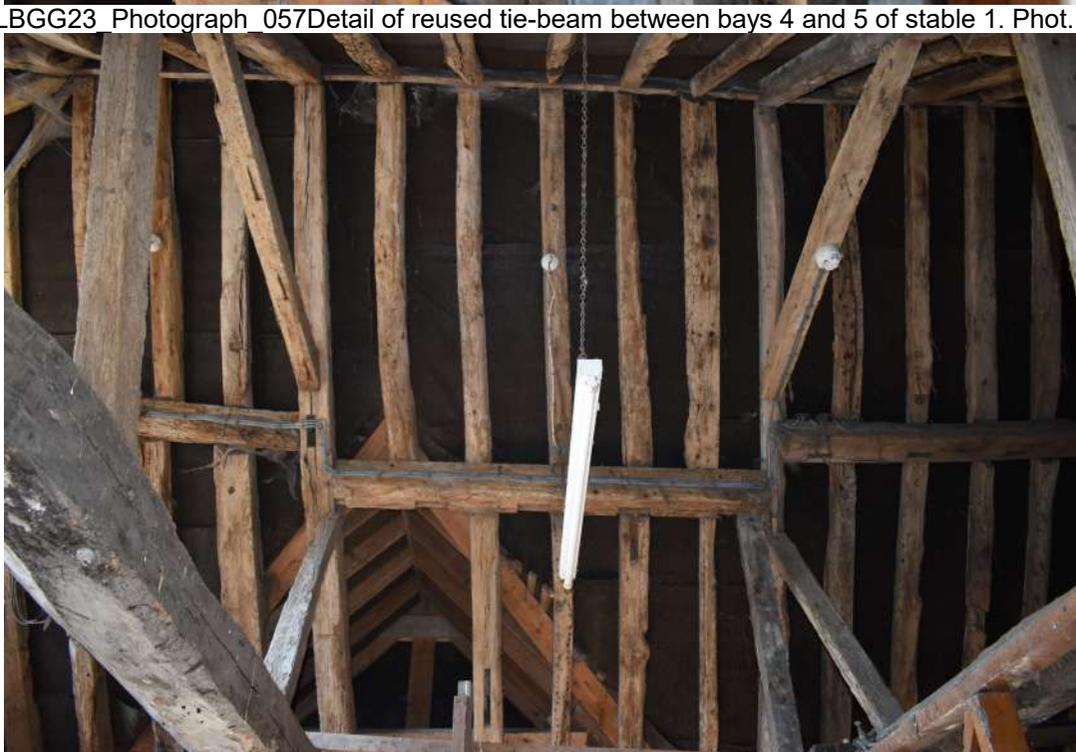
LBGG23\_Photograph\_057Detail of reused tie-beam between bays 4 and 5 of stable 1. Phot...

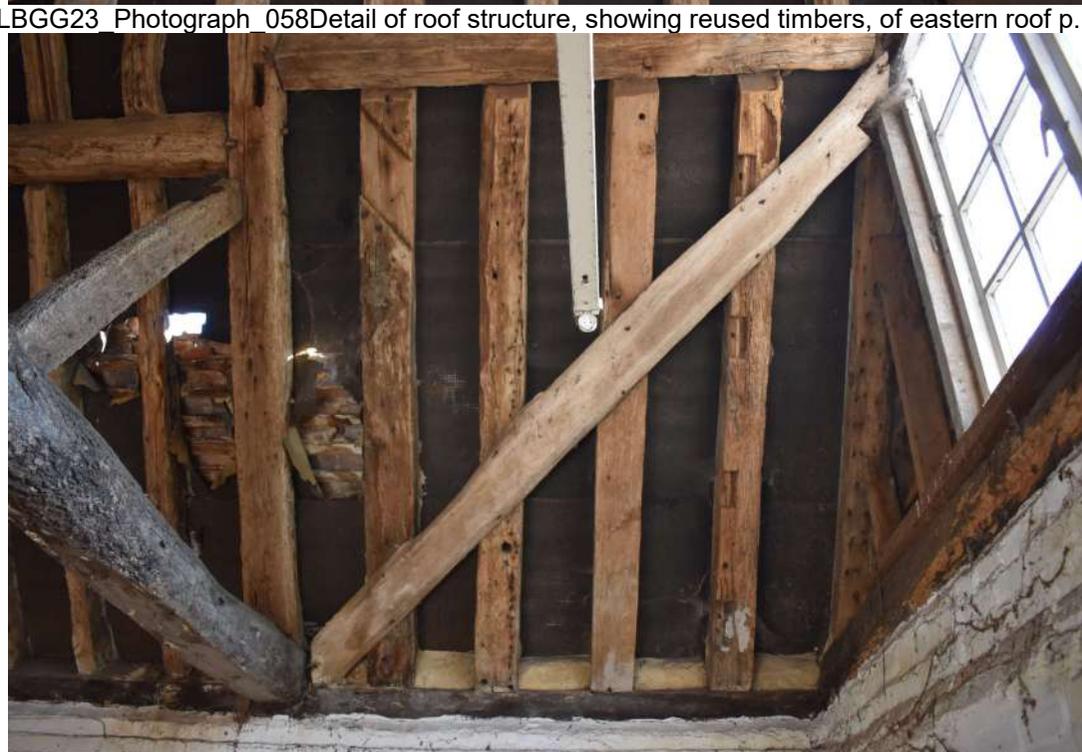
LBGG23\_Photograph\_058Detail of roof structure, showing reused timbers, of eastern roof p...

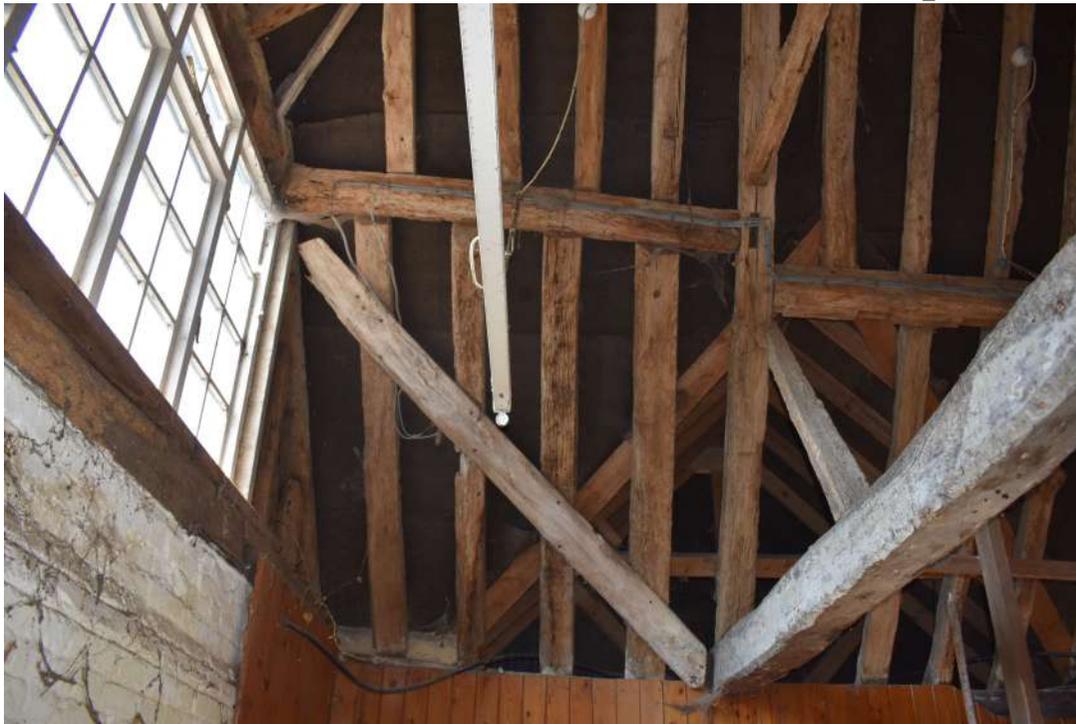
LBGG23\_Photograph\_059Detail of roof structure, showing reused timbers, of western roof p...

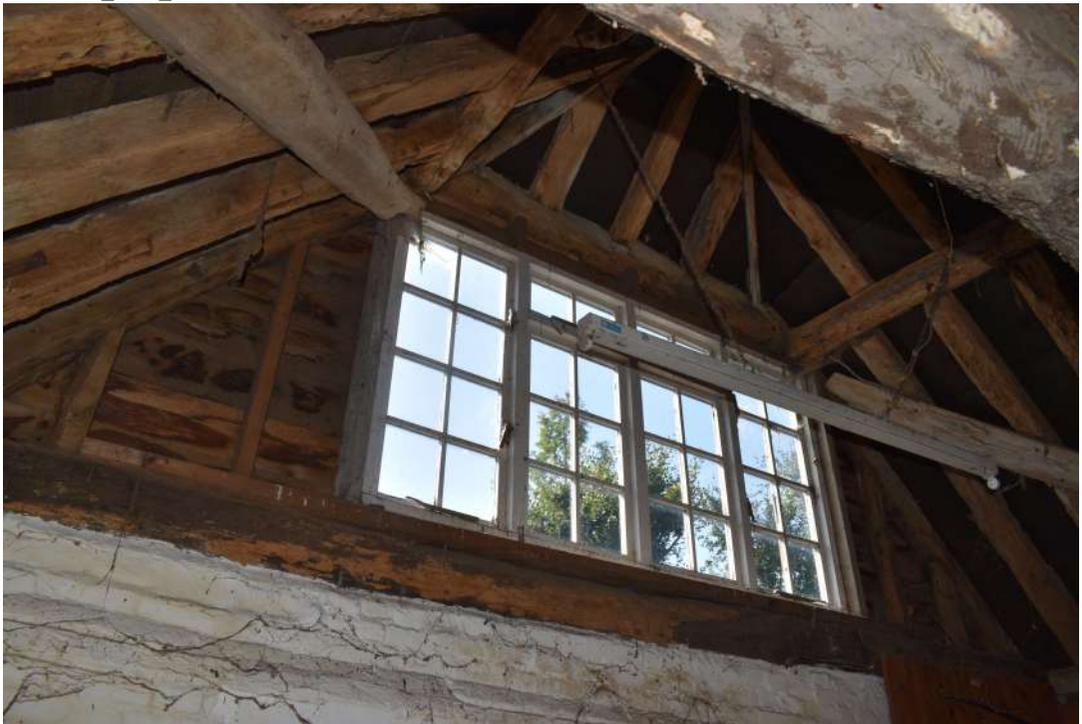
LBGG23\_Photograph\_060Detail of roof structure, showing reused timbers, of eastern roof p...

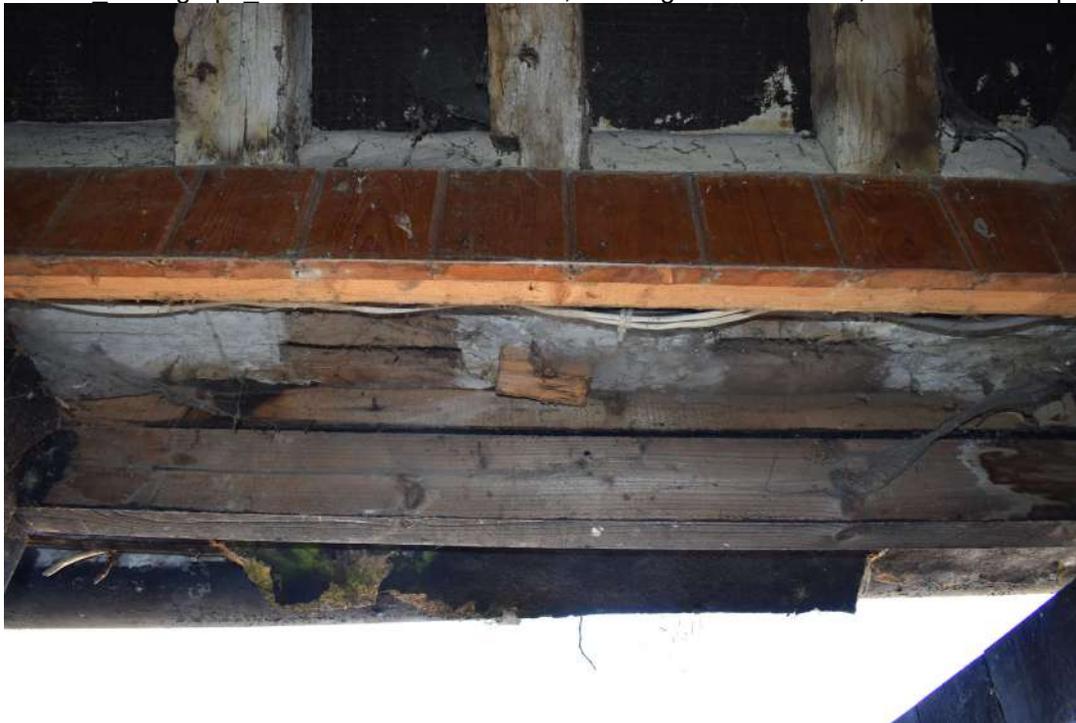
LBGG23 Photograph\_061Detail of roof structure, showing reused timbers, of western roof p...
